Re: P468700 (Contract No. P469716) Downs Park Shoreline Improvements
30% Schematic Design

Downs Park Shoreline Improvements

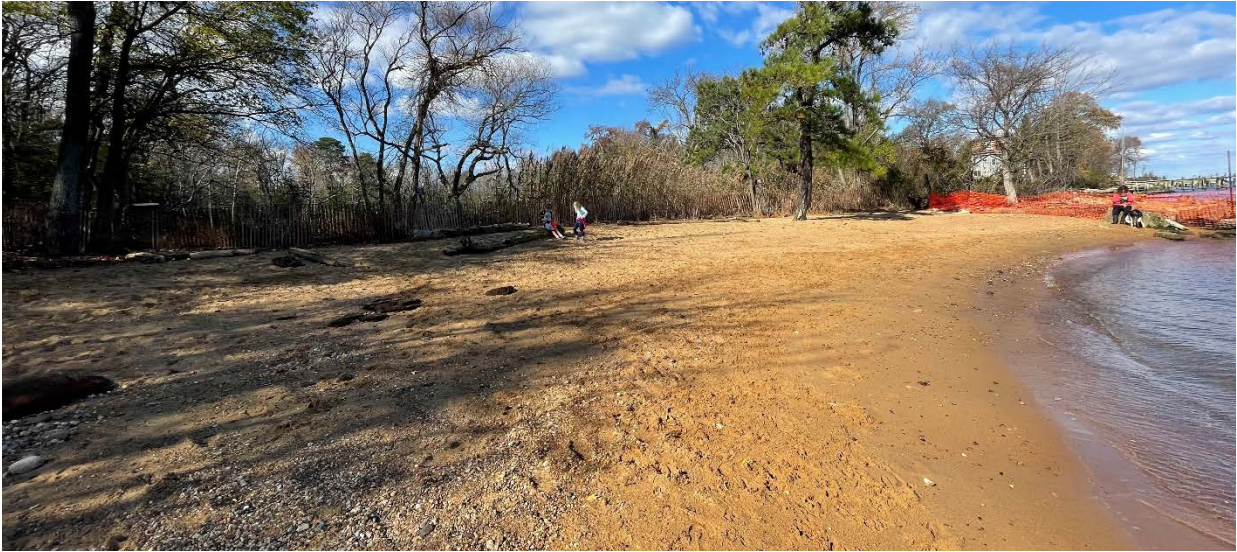
The existing dog beach (Photo 1) is located at the northern most extent of the Chesapeake Bay shoreline. A set of stairs leads down from the walking path (Photo 2), located at approximately elevation +12.5 feet Mean Low Water (MLW), to the beach at +3 feet MLW. The beach is bordered by a concrete wall to the north (Photo 3) and a revetment to the south (Photo 4). The back of the beach contains a sand fence that separates the dog beach area from the marsh and pond area just west of the beach (Photo 5). A blaze orange fence was placed along the northern concrete wall to discourage visitors from moving onto private property.

Photo 1 – Dog Beach Area (looking Northwest)

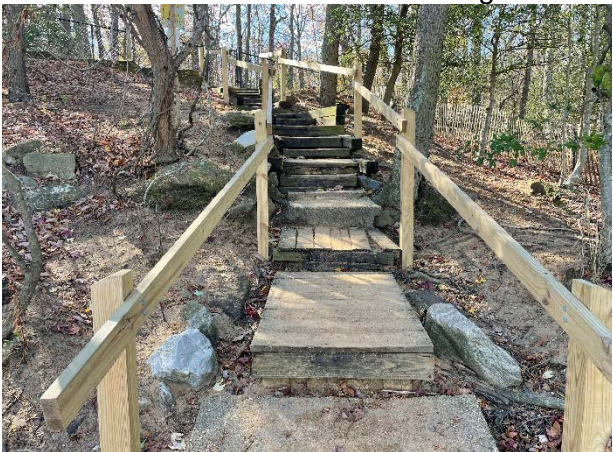
Photo 2 - Stairs leading to Dog Beach Area

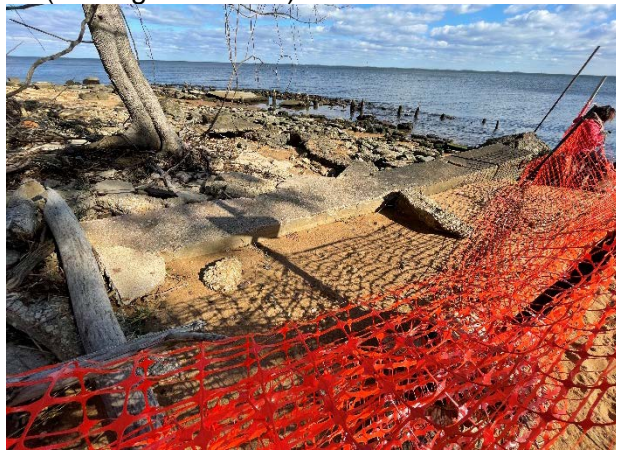
Photo 3 – Concrete Wall at North End

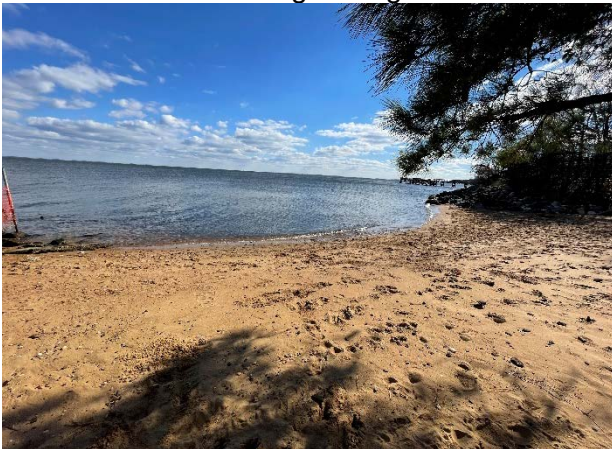
Photo 4 – Beach and Revetment at South End

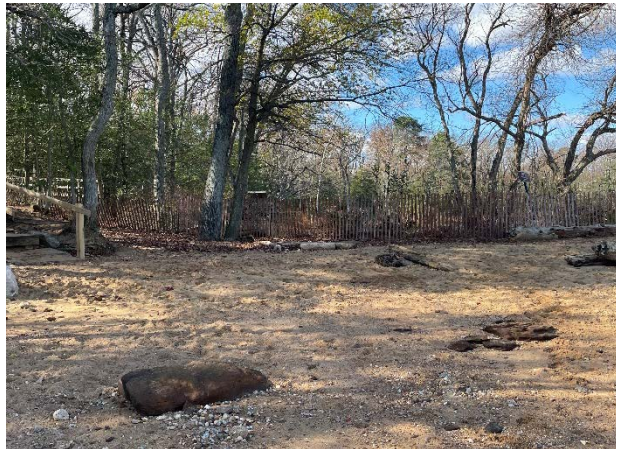
Photo 5 – Sand Fence and Pond Marsh Area

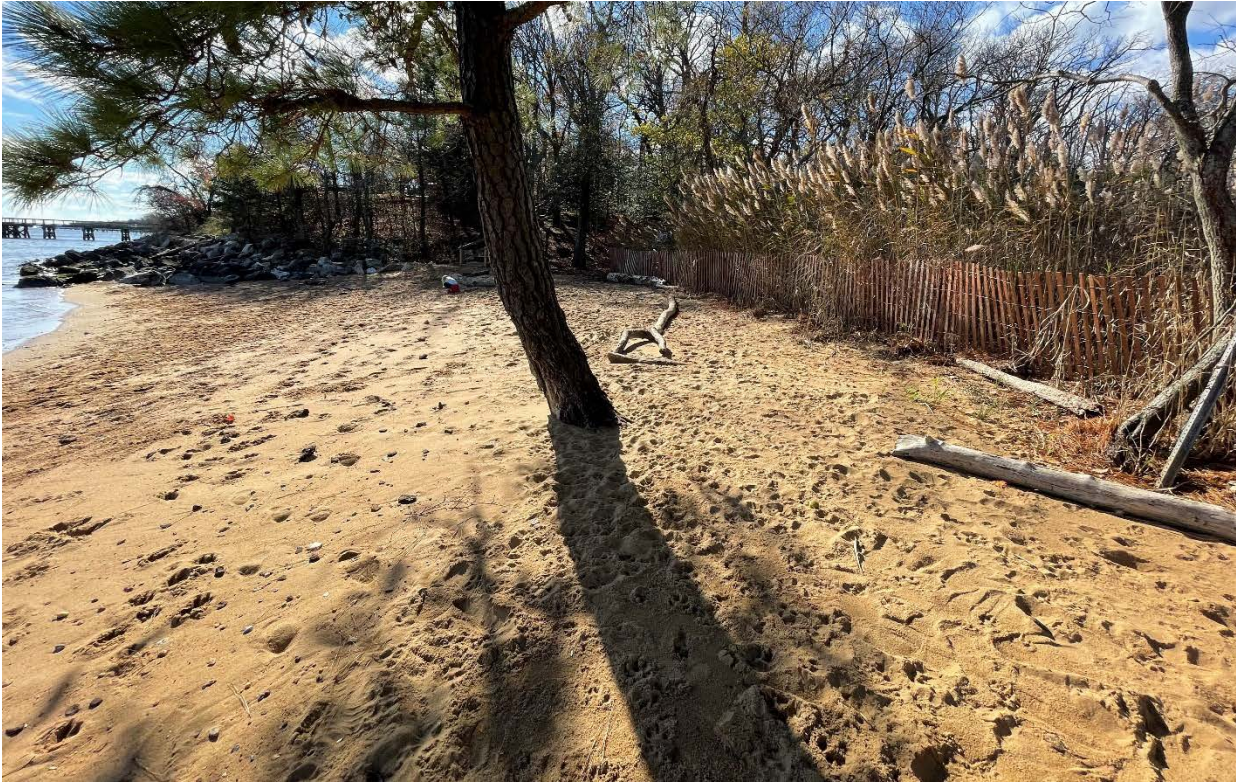
Photo 6 – Dog Beach (looking South)

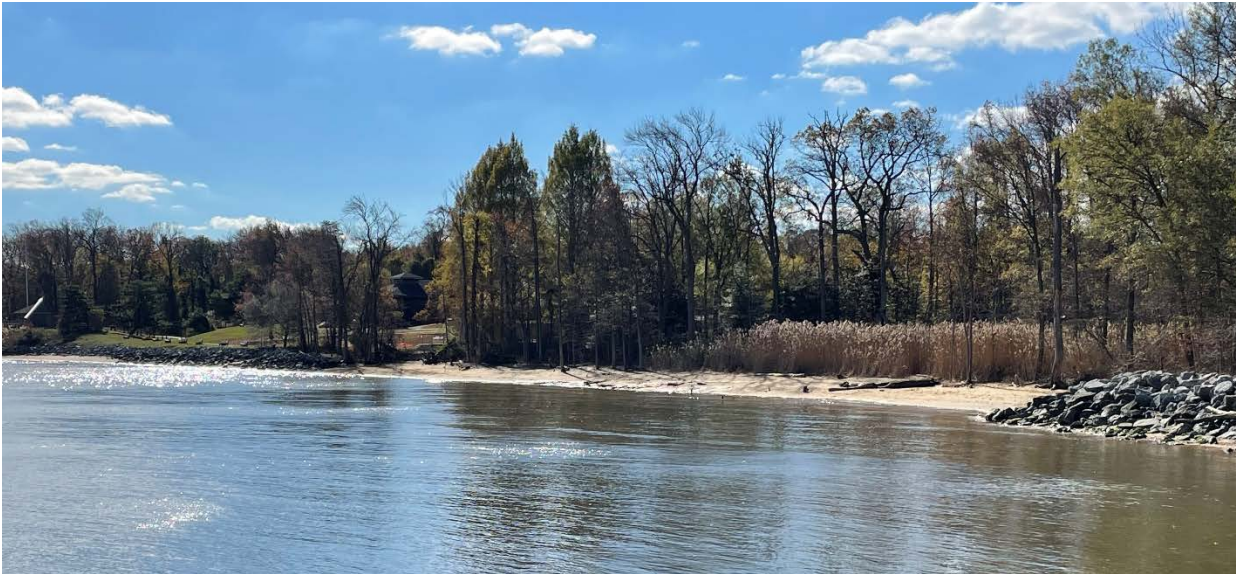
The beach south of the fishing pier is adjacent to revetment on both sides (Photo 7). The current width of the beach is less than 20 feet and has a documented erosion rate of 1 foot/year.¹ On the northern end of the beach, a trodden path leads from the main paved paths around the Park to the beach area, serving as access to the beach area and ad-hoc kayak launch (Photo 8 and 9). Adjacent to the path, the beach fronts a phragmites marsh (Photo 10) that likely collects stormwater from higher elevations in the park and is tidally influenced during periods of high tide. The beach area in front of this marsh is approximately +3 feet above MLW. The southern portions of the beach are backed by low, vegetated banks and forested areas with a paved walking trail (Photo 11). At the narrowest point located where the beach ties into the southern revetment, the paved walking trail is located less than 30 feet from the shoreline. This area has the highest rates of erosion along the beach, resulting in a recent path blow-out that occurred during the high-water event of October 29, 2021 (Photo 12). Another ad-hoc trodden path leads from the paved walking path to the beach area at this location (Photo 13).

Photo 7 – Southern Beach (looking Southwest from Fishing Pier)

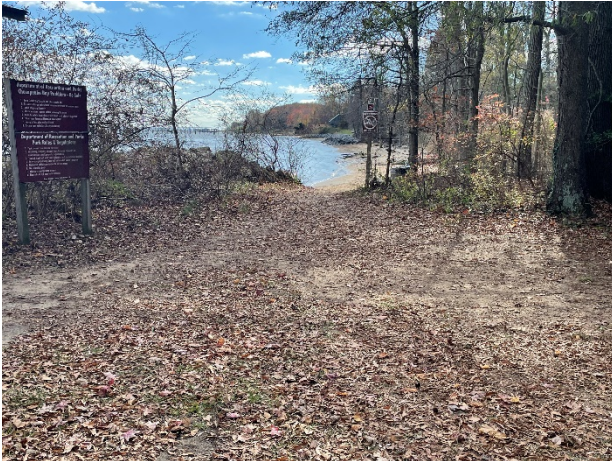
Photo 8 – Path to Beach Area (looking South)

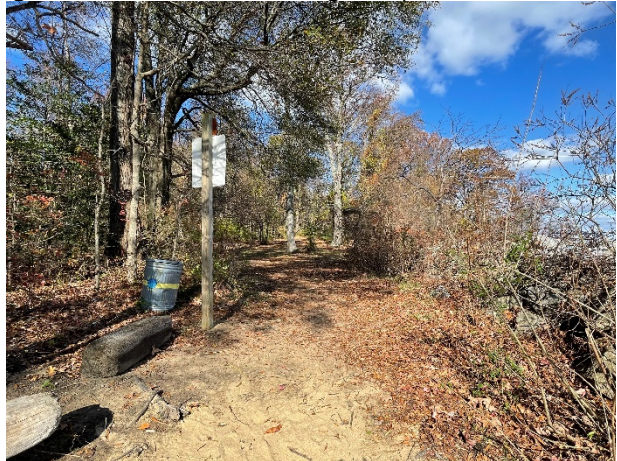
Photo 9 – Path to Beach Area (looking North)

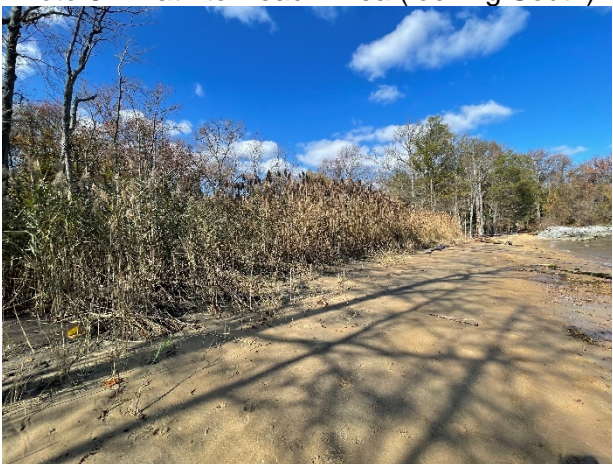
Photo 10 – Phragmites Marsh along Back beach (looking North)

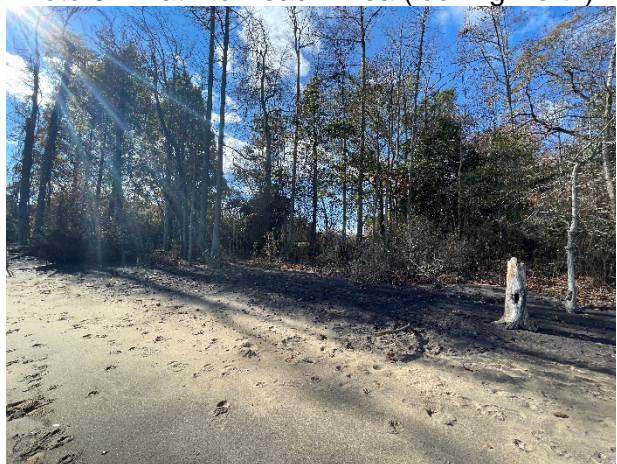
Photo 11 – Shoreline south of Phragmites Marsh backed by forest area

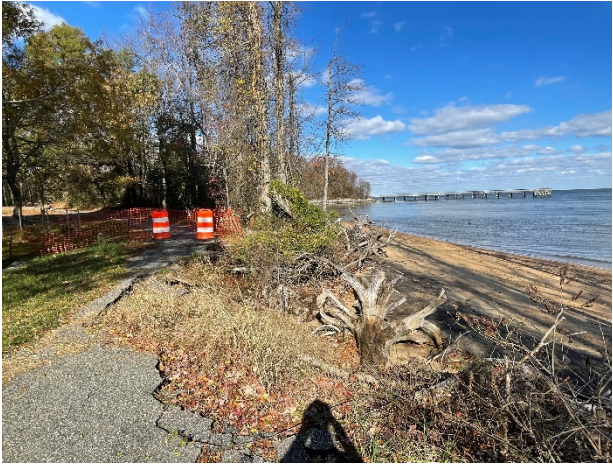
Photo 12 – Path Blown Out behind Narrowest Part of Beach

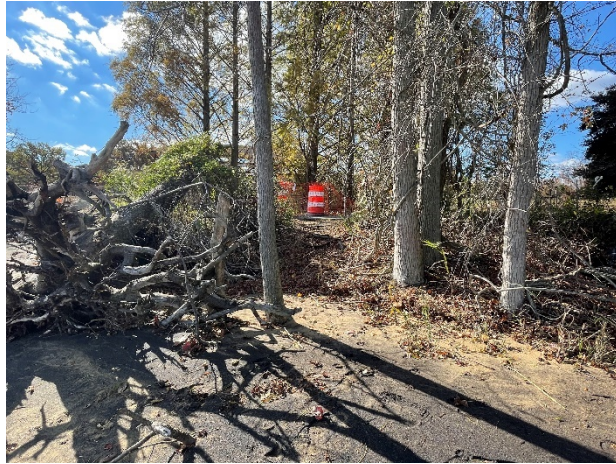
Photo 13 – Trodden Path leading to Beach

The preferred alternative for shoreline protection along this area is a combination of beach nourishment and living shoreline. The existing ad-hoc path at the northern end of the shoreline reach is proposed to be formalized into an ADA-compliant permeable paver path that connects the beach to the existing paved walking trails within the Park. The dog beach is proposed to be moved to the area in front of the revetment where sand fill will be placed. A headland breakwater structure will be constructed to an elevation of +5 feet above MLW to provide adequate protection to the newly placed sand for the dog beach.

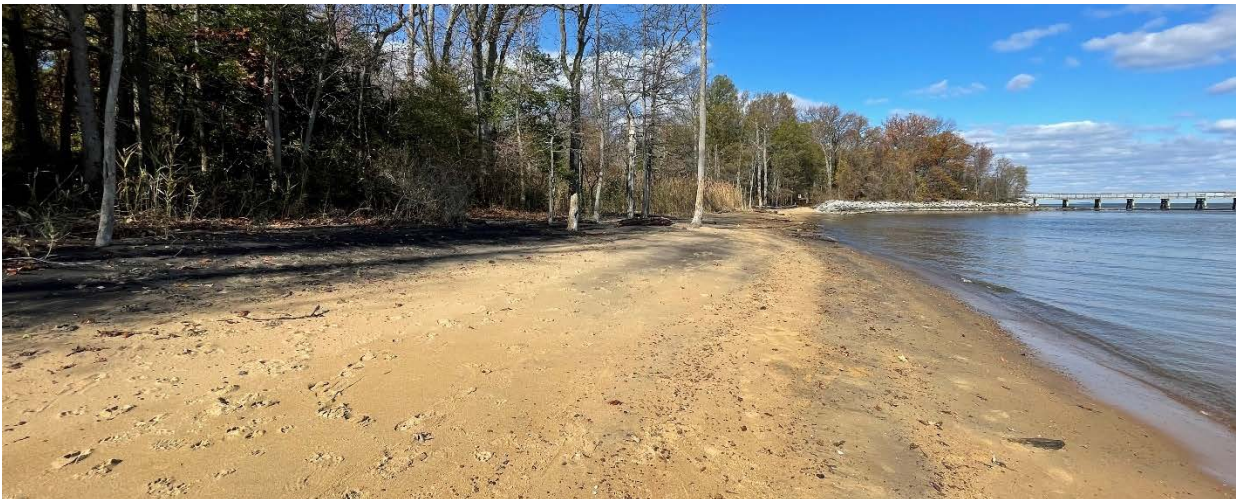
Photo 14 – Beach Area (looking north)

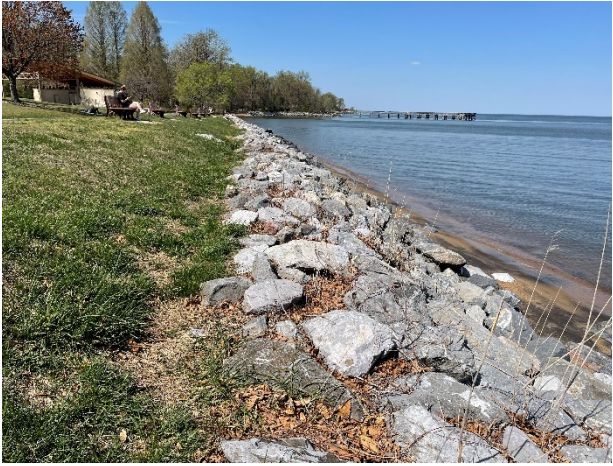
As part of the 30% Schematic Design Phase, the revetment to the south of the beach was assessed to determine its condition. During the site investigation, the revetment was observed to consist of large stones that are haphazardly placed or dumped along the shoreline. The presence of geotextile fabric and some remnants of a crest apron (stone landward of the structure to prevent scour from overtopping waves) indicate the stone may have been constructed as a revetment once but has lost its structural integrity. Voids with vegetation growing through them were observed as the stone was not properly interlocked. Additionally, the lack of interlocking was observed as stones from the structure appeared to be scattered either seaward (Photo 16) or landward (Photo 17) of the structure. Multiple washout areas (areas eroded by waves overtopping the slope protection structure) were observed (Photo 18), indicating that the structure is not dissipating wave energy efficiently. In the northern portion of revetment, closest to the existing beach area proposed for protection, the structure appears to be more robust, with multiple layers of stone placed (Photos 19 and 20).

Elevation measurements taken of the revetment during the November 2022 field investigations indicate the structure has a top elevation between +6 and +8 feet above MLW, typically considered appropriate for revetments along the Chesapeake Bay. However, due to the lack of structure crest and apron, the structure does not provide adequate wave protection.

Photo 15 – Stone Slope Protection with Voids

Three options were considered for implementing improvements to the Southern Revetment. The first alternative consists of performing maintenance of the structure by backfilling the washout areas behind the structure crest. This option aims only to repair damage caused by previous storms and does not offer additional protection for future high wave or water level events. This option could be implemented by DRP staff or could be contracted out at a cost not expected to exceed \$10,000 - \$15,000.

The second option would be to rebuild the crest and apron of the revetment while leaving the slope and toe of the structure in their current condition. This would likely be done by adding stone to the crest and apron and re-grading the area landward of the structure. It is anticipated that this option will repair existing damage as well as provide protection for approximately the next 10 years. This option is anticipated to cost approximately \$75,000.

To improve the performance of the revetment in protecting the shoreline for a longer term, the third option recommends that a more formalized revetment be constructed along this area. The proposed revetment would build an appropriate crest and apron for future water levels and slope down at 2 feet horizontal to 1 foot vertical to 0 feet MLW. A five-foot wide toe would be constructed to support the structure. It is anticipated that these improvements would provide protection for the next 50+ years and would cost approximately \$250,000.

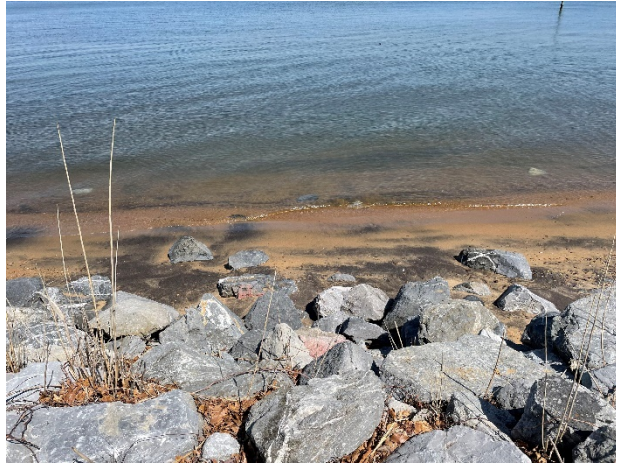
Photo 16 – Stones Scattered Seaward of Structure

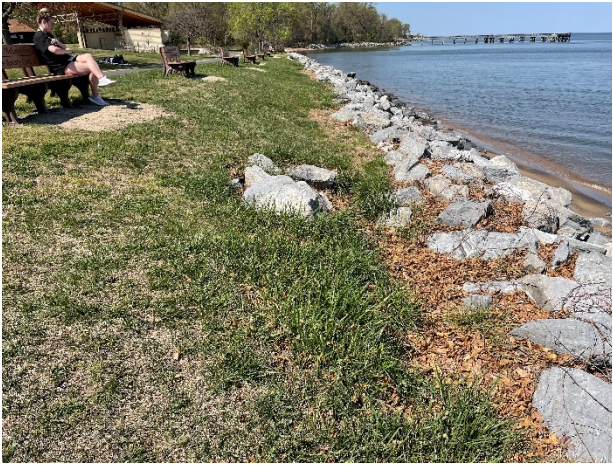
Photo 17 – Stones Pushed back off Structure

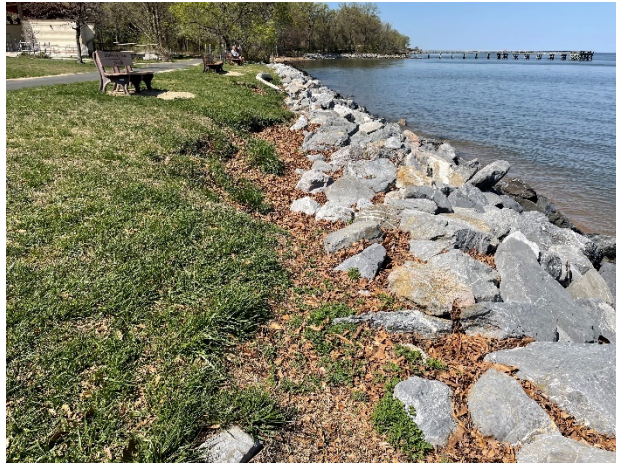
Photo 18 – Multiple Washout Areas behind Structure

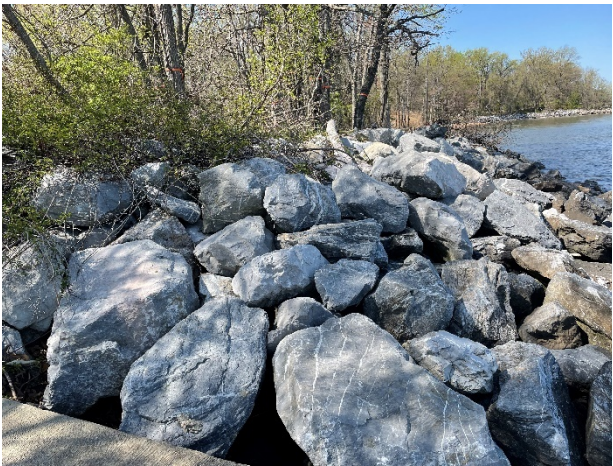
Photo 19 – Larger Revetment at Northern End (looking North)

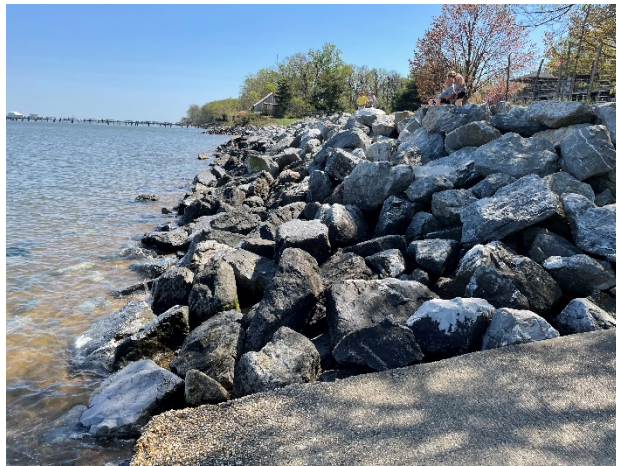
Photo 20 – Larger Revetment at Northern End (looking South)
