PPOIGGS22.23801 Epping Forest Marina Design/Drawings/CADIEFBC Marina Basin_082123.dwg Exhibit A 9/21/23

Epping Forest – Variance Application – 2023-0136-V

PHOTOS OF CURRENT CONDITIONS AT MARINA

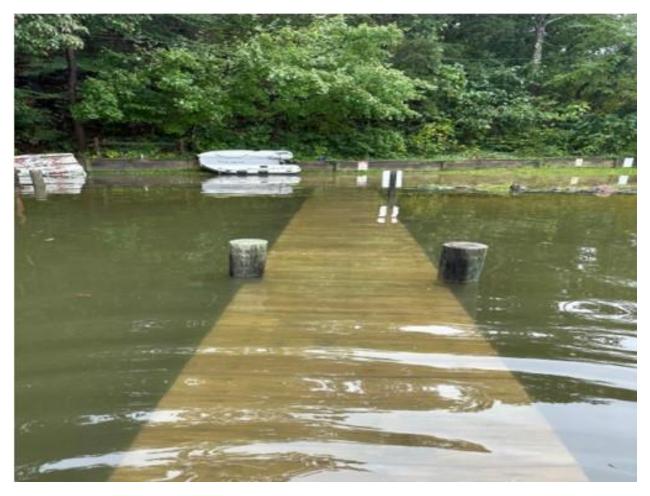
Pier is underwater during storms and surges – occurs 6- 8 times a year and has increased over the years. Current pier is too low and does not meet current regulatory standards.

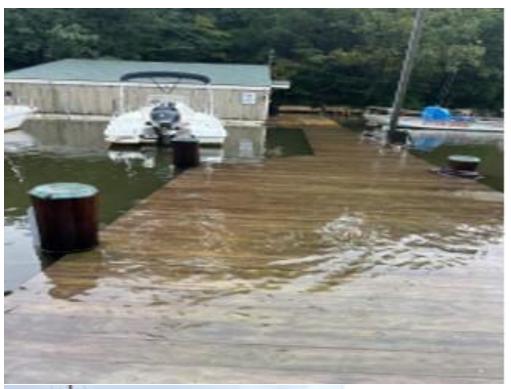
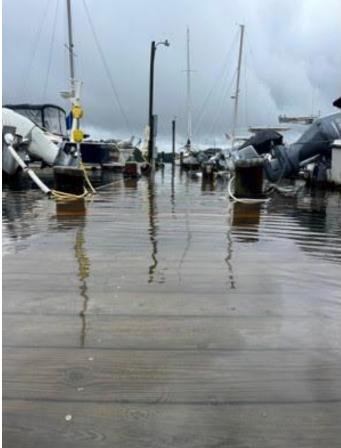
Pier is underwater during storms and surges – occurs 6-8 times a year and has increased over the years

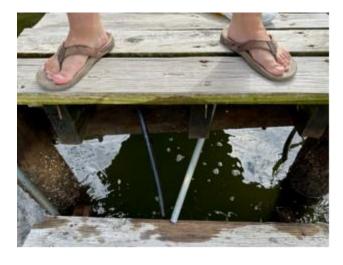
Areas of piers broken off and fallen into water. Hazard tape prohibiting access during repairs. More failing areas each season. The scope of failures are beyond general maintenance such as repairs to singular deck boards or new nails or screws in specific boards.
