## TECHNICAL MEMORANDUM

TO: File  
FROM: Erik Terry, Engineer III, Traffic Engineering Division  
SUBJECT: Riedel Road - Midblock Trail Crossing  
DATE: January 1, 2024

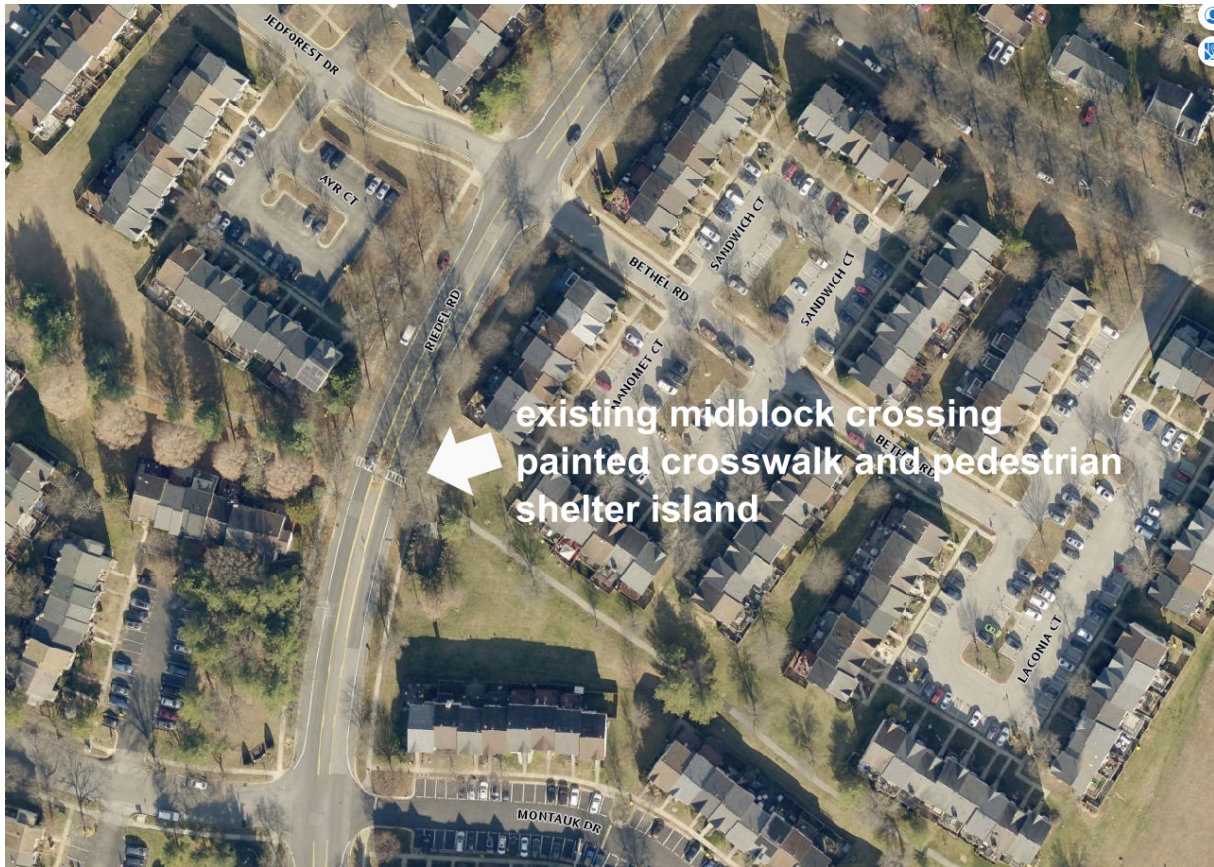
Aerial photo showing location of subject mid block pedestrian crossing

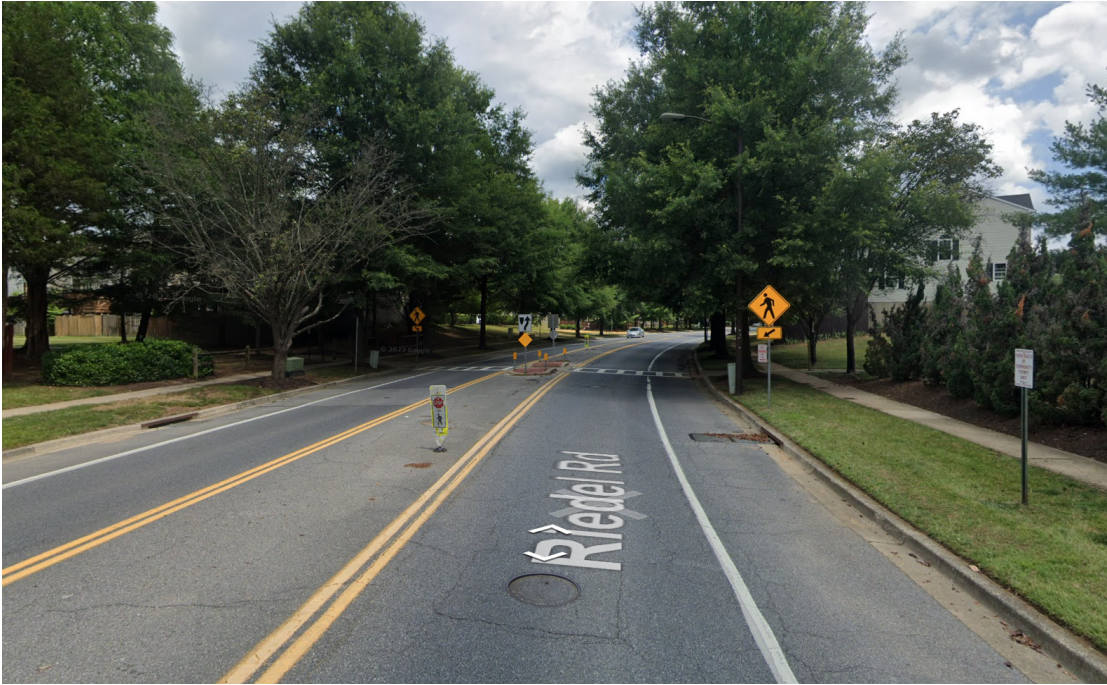
Northbound approach

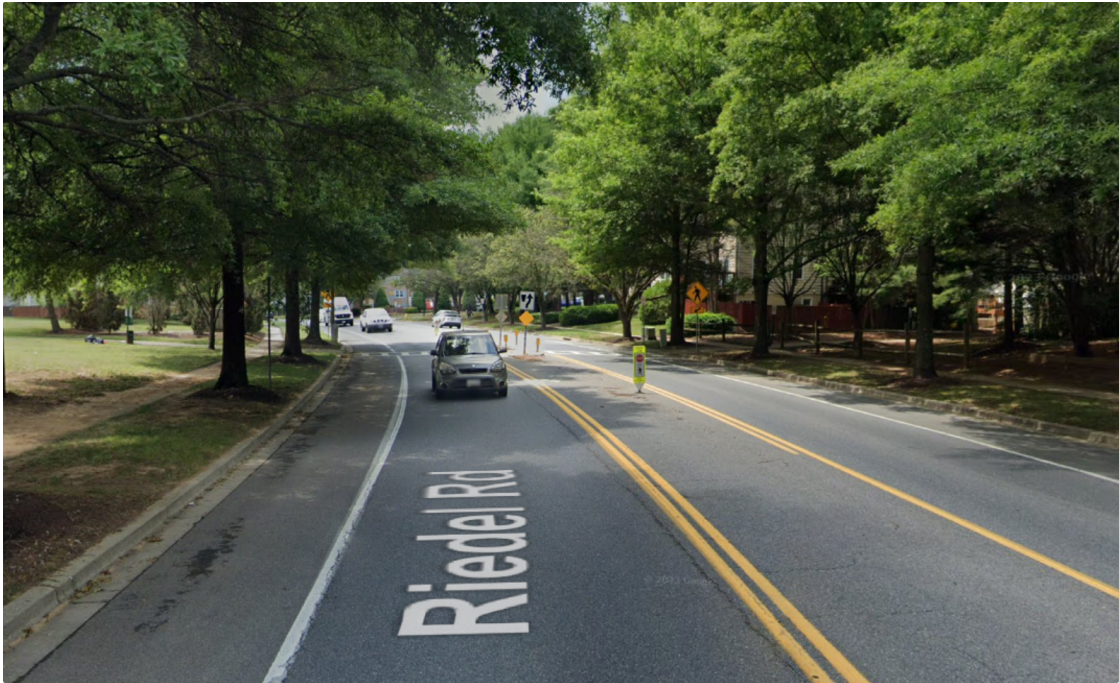
Southbound approach

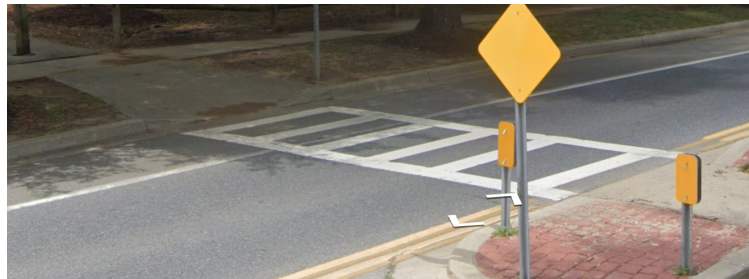
- Crossing type: mid-block
- Roadway configuration: NB - 1 thru lane. SB - 1 thru lane. Between the two travel lanes is a TWLTL which becomes a painted median near the crossing. There is a ~6' shoulder area defined by a solid white edge line on both sides of the road.
- Marked crosswalk - High visibility ladder style

- Crossing length – 50 feet (from curb to curb), 18 feet (from handicap ramp to pedestrian shelter island), 11 feet (across single travel lane)
- Signage for pedestrians: none
- Signage for vehicles:

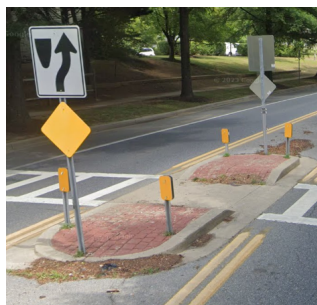
<p>Sign clutter adds to driver confusion</p>
---	--

- Pedestrian signals: none
- Other pedestrian amenities: pedestrian shelter island

- Upgrade pedestrian warning signage to trail crossing warning signs (hiker/biker)
- Improve visibility of signage (replacement/relocation)
- Remove sign clutter
- Install stop signs for trail crossing

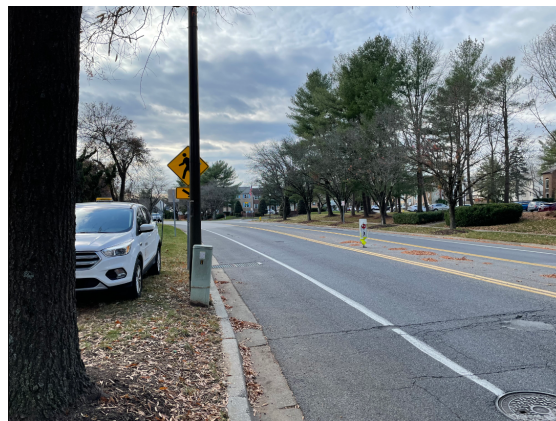
Field measured: 204' from east side of crossing (northbound vehicles). 204' will be used for calculations as it is the minimum measured stopping sight distance for the crossing and is the constraining factor.

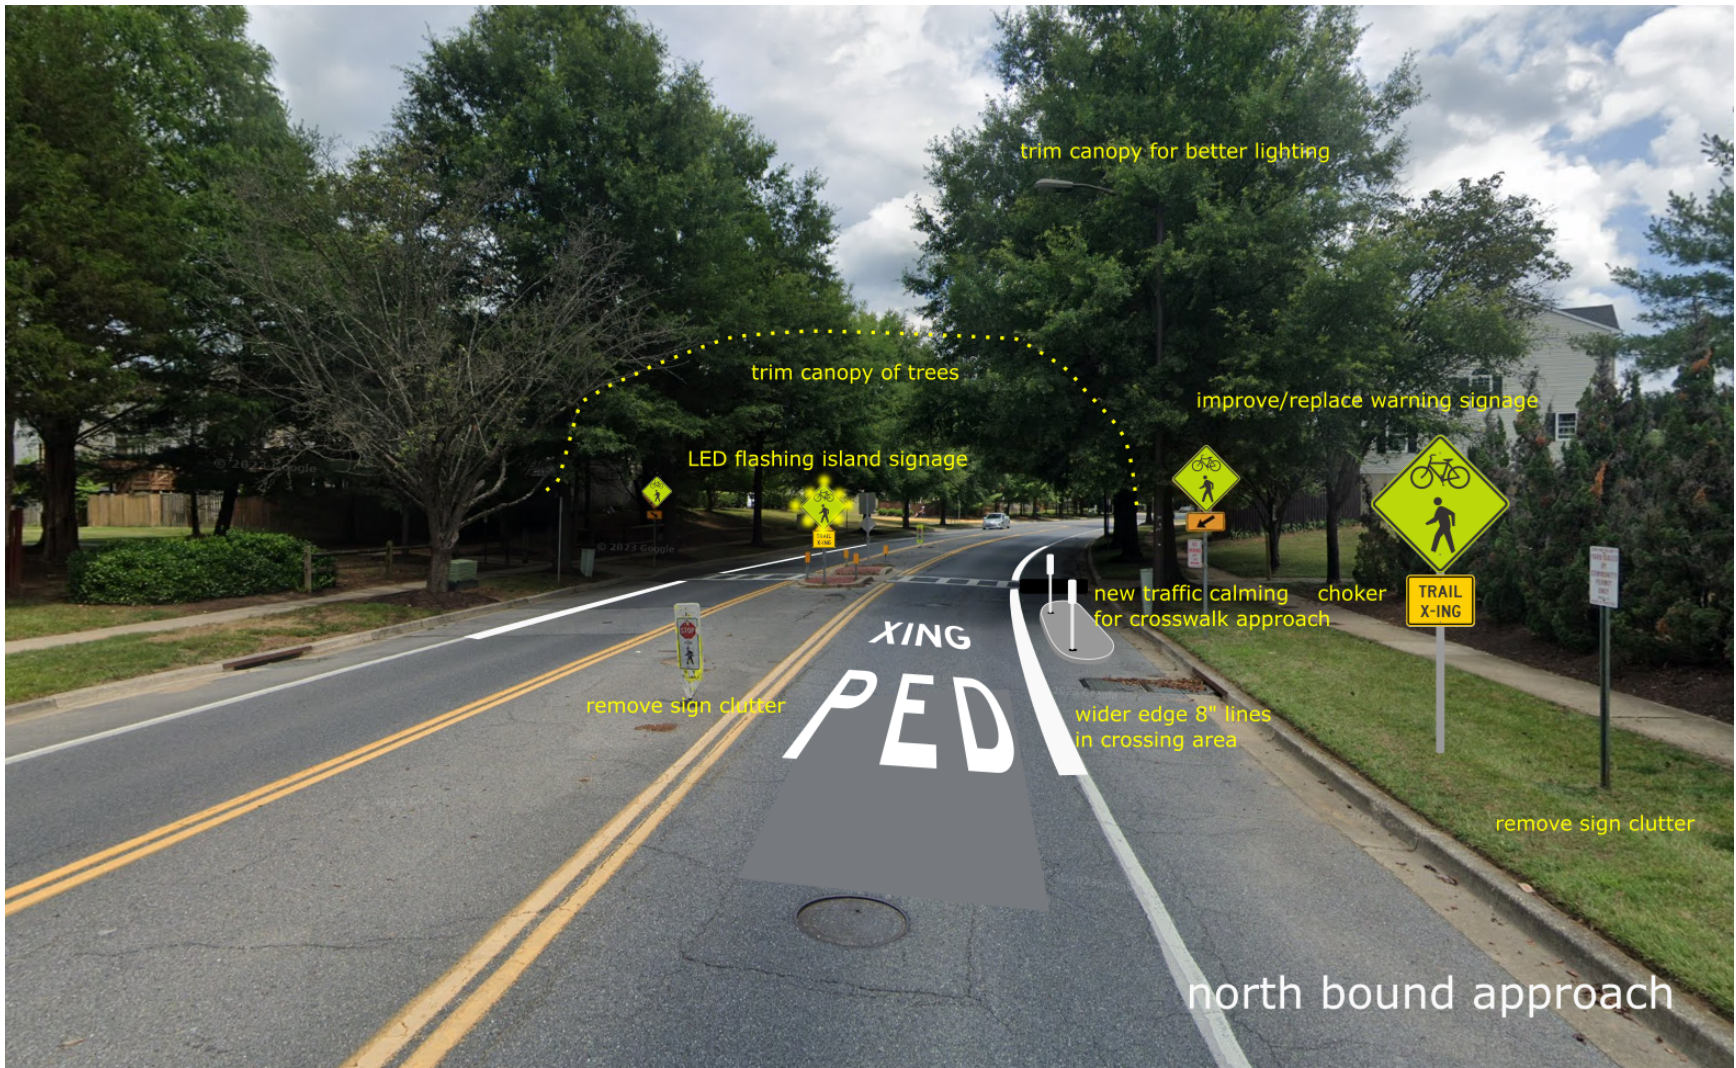
*Photo showing some of the potential trail crossing enhancements*

- Bring curb ramping up to ADA compliance
- Stop signs for trail users
- Detectable warning surfaces on ramping (truncated domes)
- Detectable warning surfaces on refuge island (truncated domes)
- Trim/raise tree canopy to allow for better visibility/lighting (Road Operations)
- Traffic calming chokers in shoulder on approach to crosswalk. Allows for refuge in shoulder area and shortens crossing from 18' to 11' (travel lane). There are clear sight lines to the shoulder area.
- Remove trees to improve visibility/lighting
