Odor Control Summer Monitoring Data

Annapolis Water Reclamation Facility
Odor Control Evaluations

December 10, 2024

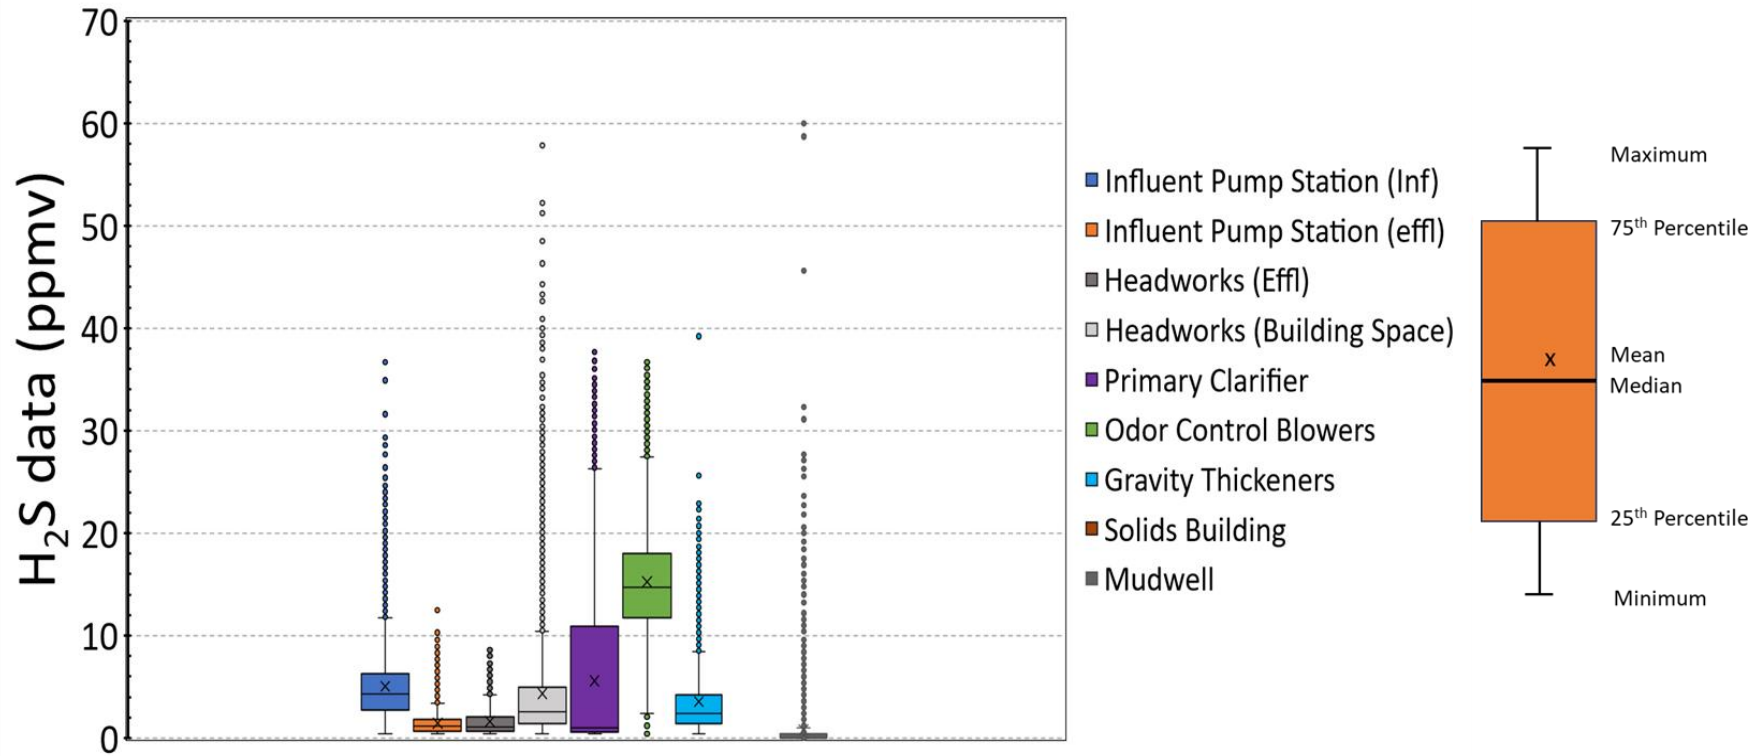
Figure 3-1: Box-And-Whisker Plots Showing the Change in Measurable H₂S Concentration Distribution for the Locations Within the WRF (July 1 to August 13).

In general, summer H₂S levels at all locations were relatively high compared to the winter data, consistent with the reasoning that warmer temperatures increase biological activity, promote the volatilization of odorous compounds, and create anaerobic conditions, leading to higher H₂S production and release.

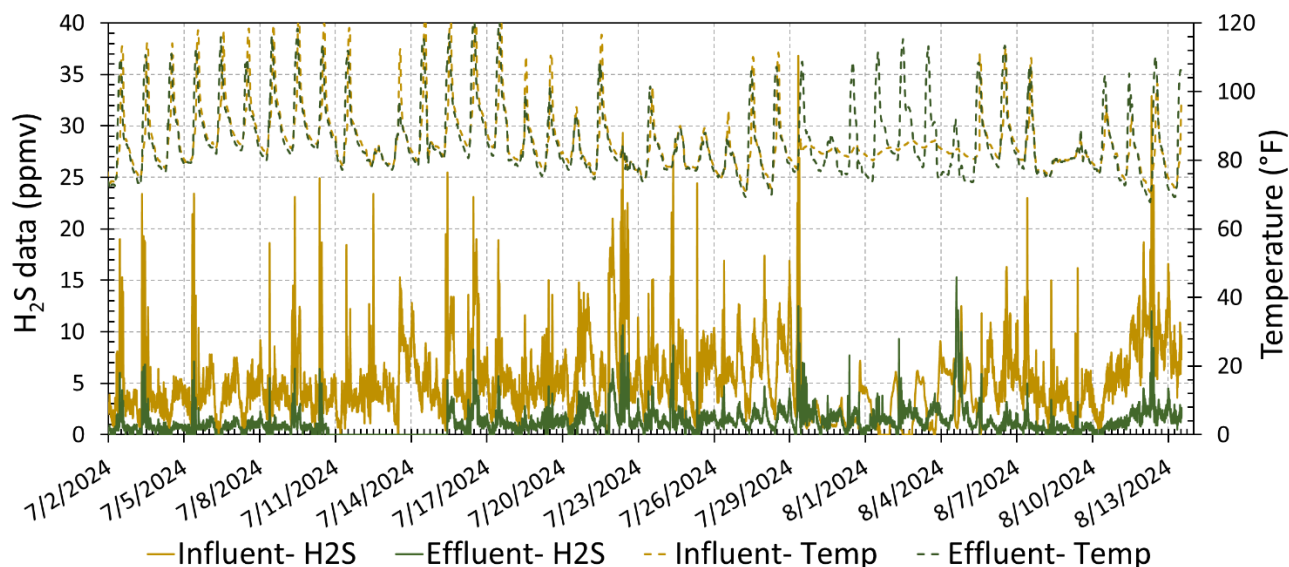
Figure 3-2: Results of Continuous Monitoring at Influent Pump Station (7/1/2024-8/13/2024)

The H₂S readings at the influent pump station are not excessive and can be effectively treated with appropriate odor control technologies (evaluated in separate TM). Although the existing biofilter is currently used for treating these odors, the effluent data shown in Figure 3-2 indicate that the existing treatment system is not effective in addressing the odorous air from the influent pump station.

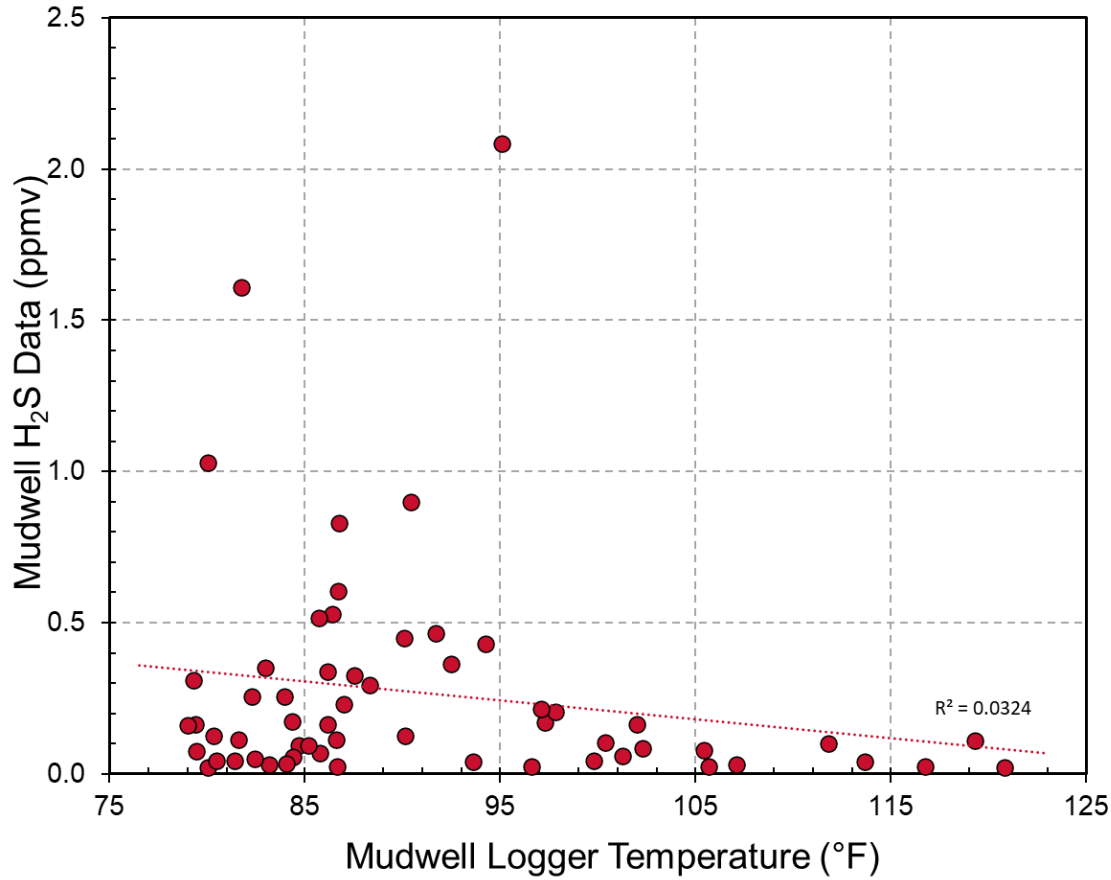
Figure 3-8 Hourly Time-Averaged Mudwell H₂S Data Plotted against Ambient Temperature Data Recorded by the Logger

The logger was located outside. Temperatures were measured in excess of 140 °F, which was likely caused by exposure to direct sunlight. This could impact overall accuracy. The peaks in the detected H₂S values seem to align with the ambient temperature peaks recorded by the logger, so a correlation plot was developed to verify this relationship. However, as seen in Figure 3-8, the hourly time-averaged H₂S emissions plotted against the hourly time-averaged temperature data did not show any clear correlation, indicating that odor emission at the mudwell is not temperature dependent.

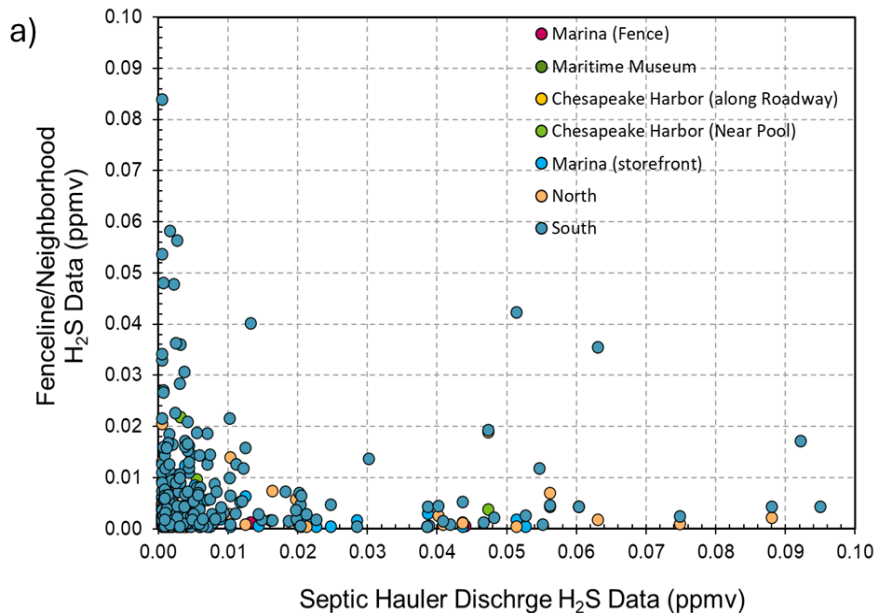
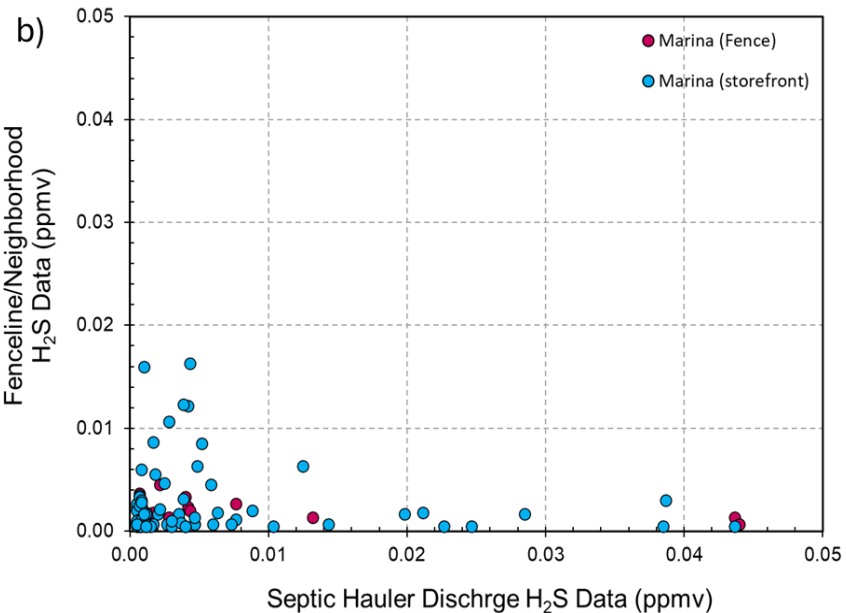
Figure 3-13: Hourly Time-Averaged Concentrations: a) Fenceline and Neighborhood Data Plotted against Septic Hauler Discharge Data; b) Marina Data Plotted against Septic Hauler Discharge Data

Figure 3-13 shows the correlation plot for the septic hauler discharge data with the other PPB loggers’ data.

No direct correlation was observed between the odor emissions from the Septic Hauler Discharge and any of the fenceline or neighborhood locations during this round of odor monitoring.

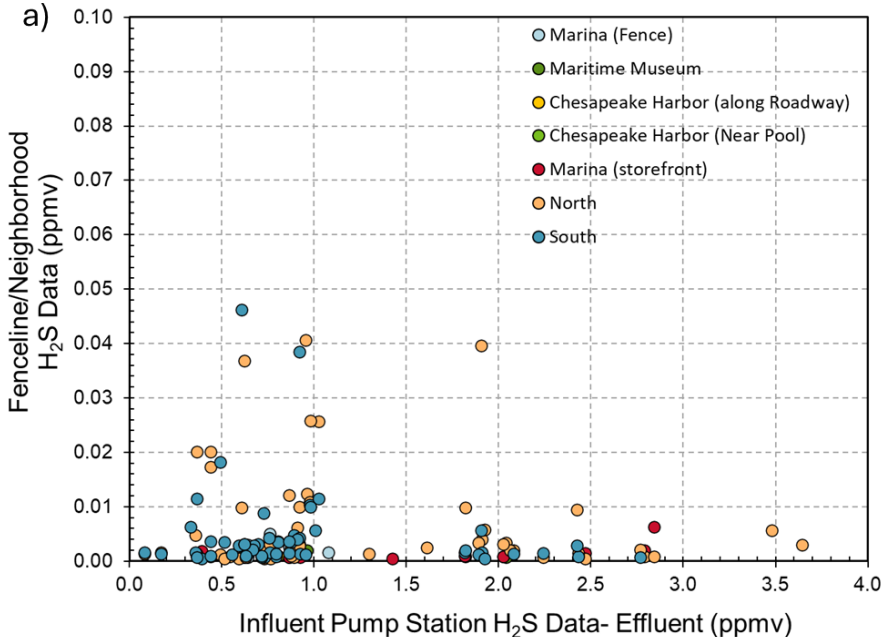
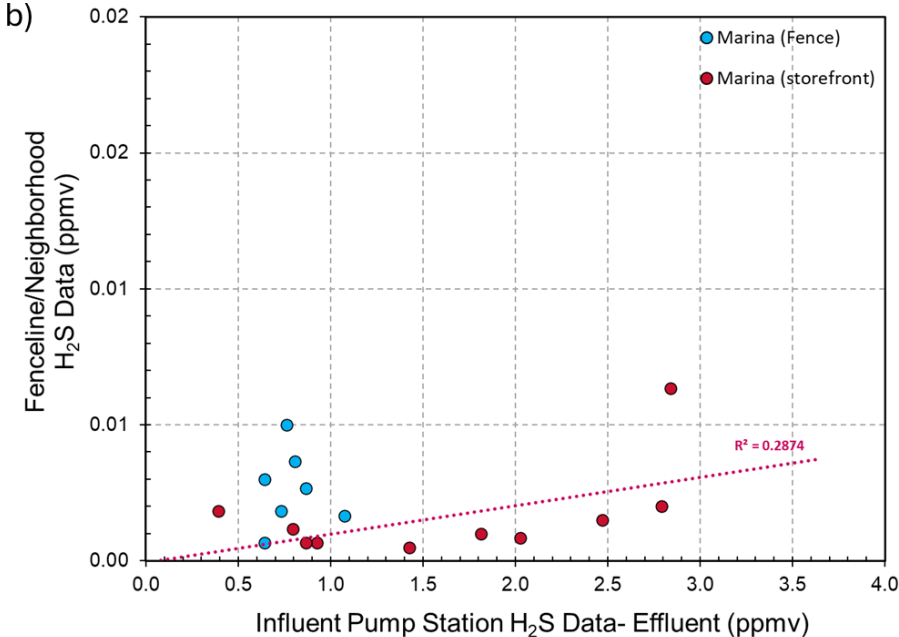
Figure 3-15: Hourly Time-Averaged Concentrations: a) Fenceline and Neighborhood Data Plotted against Influent Pump Station Effluent Data; b) Marina Data Plotted against Influent Pump Station Effluent Data

Figure 3-15 shows the correlation plot for the influent pump station effluent data with the other PPB loggers' data. No strong correlation was observed between the odor emissions from the IPS effluent and any of the fenceline or neighborhood locations during this round of odor monitoring, except for the data collected at the marina storefront. The odor data from the marina storefront closely correlated with the influent pump station effluent data.

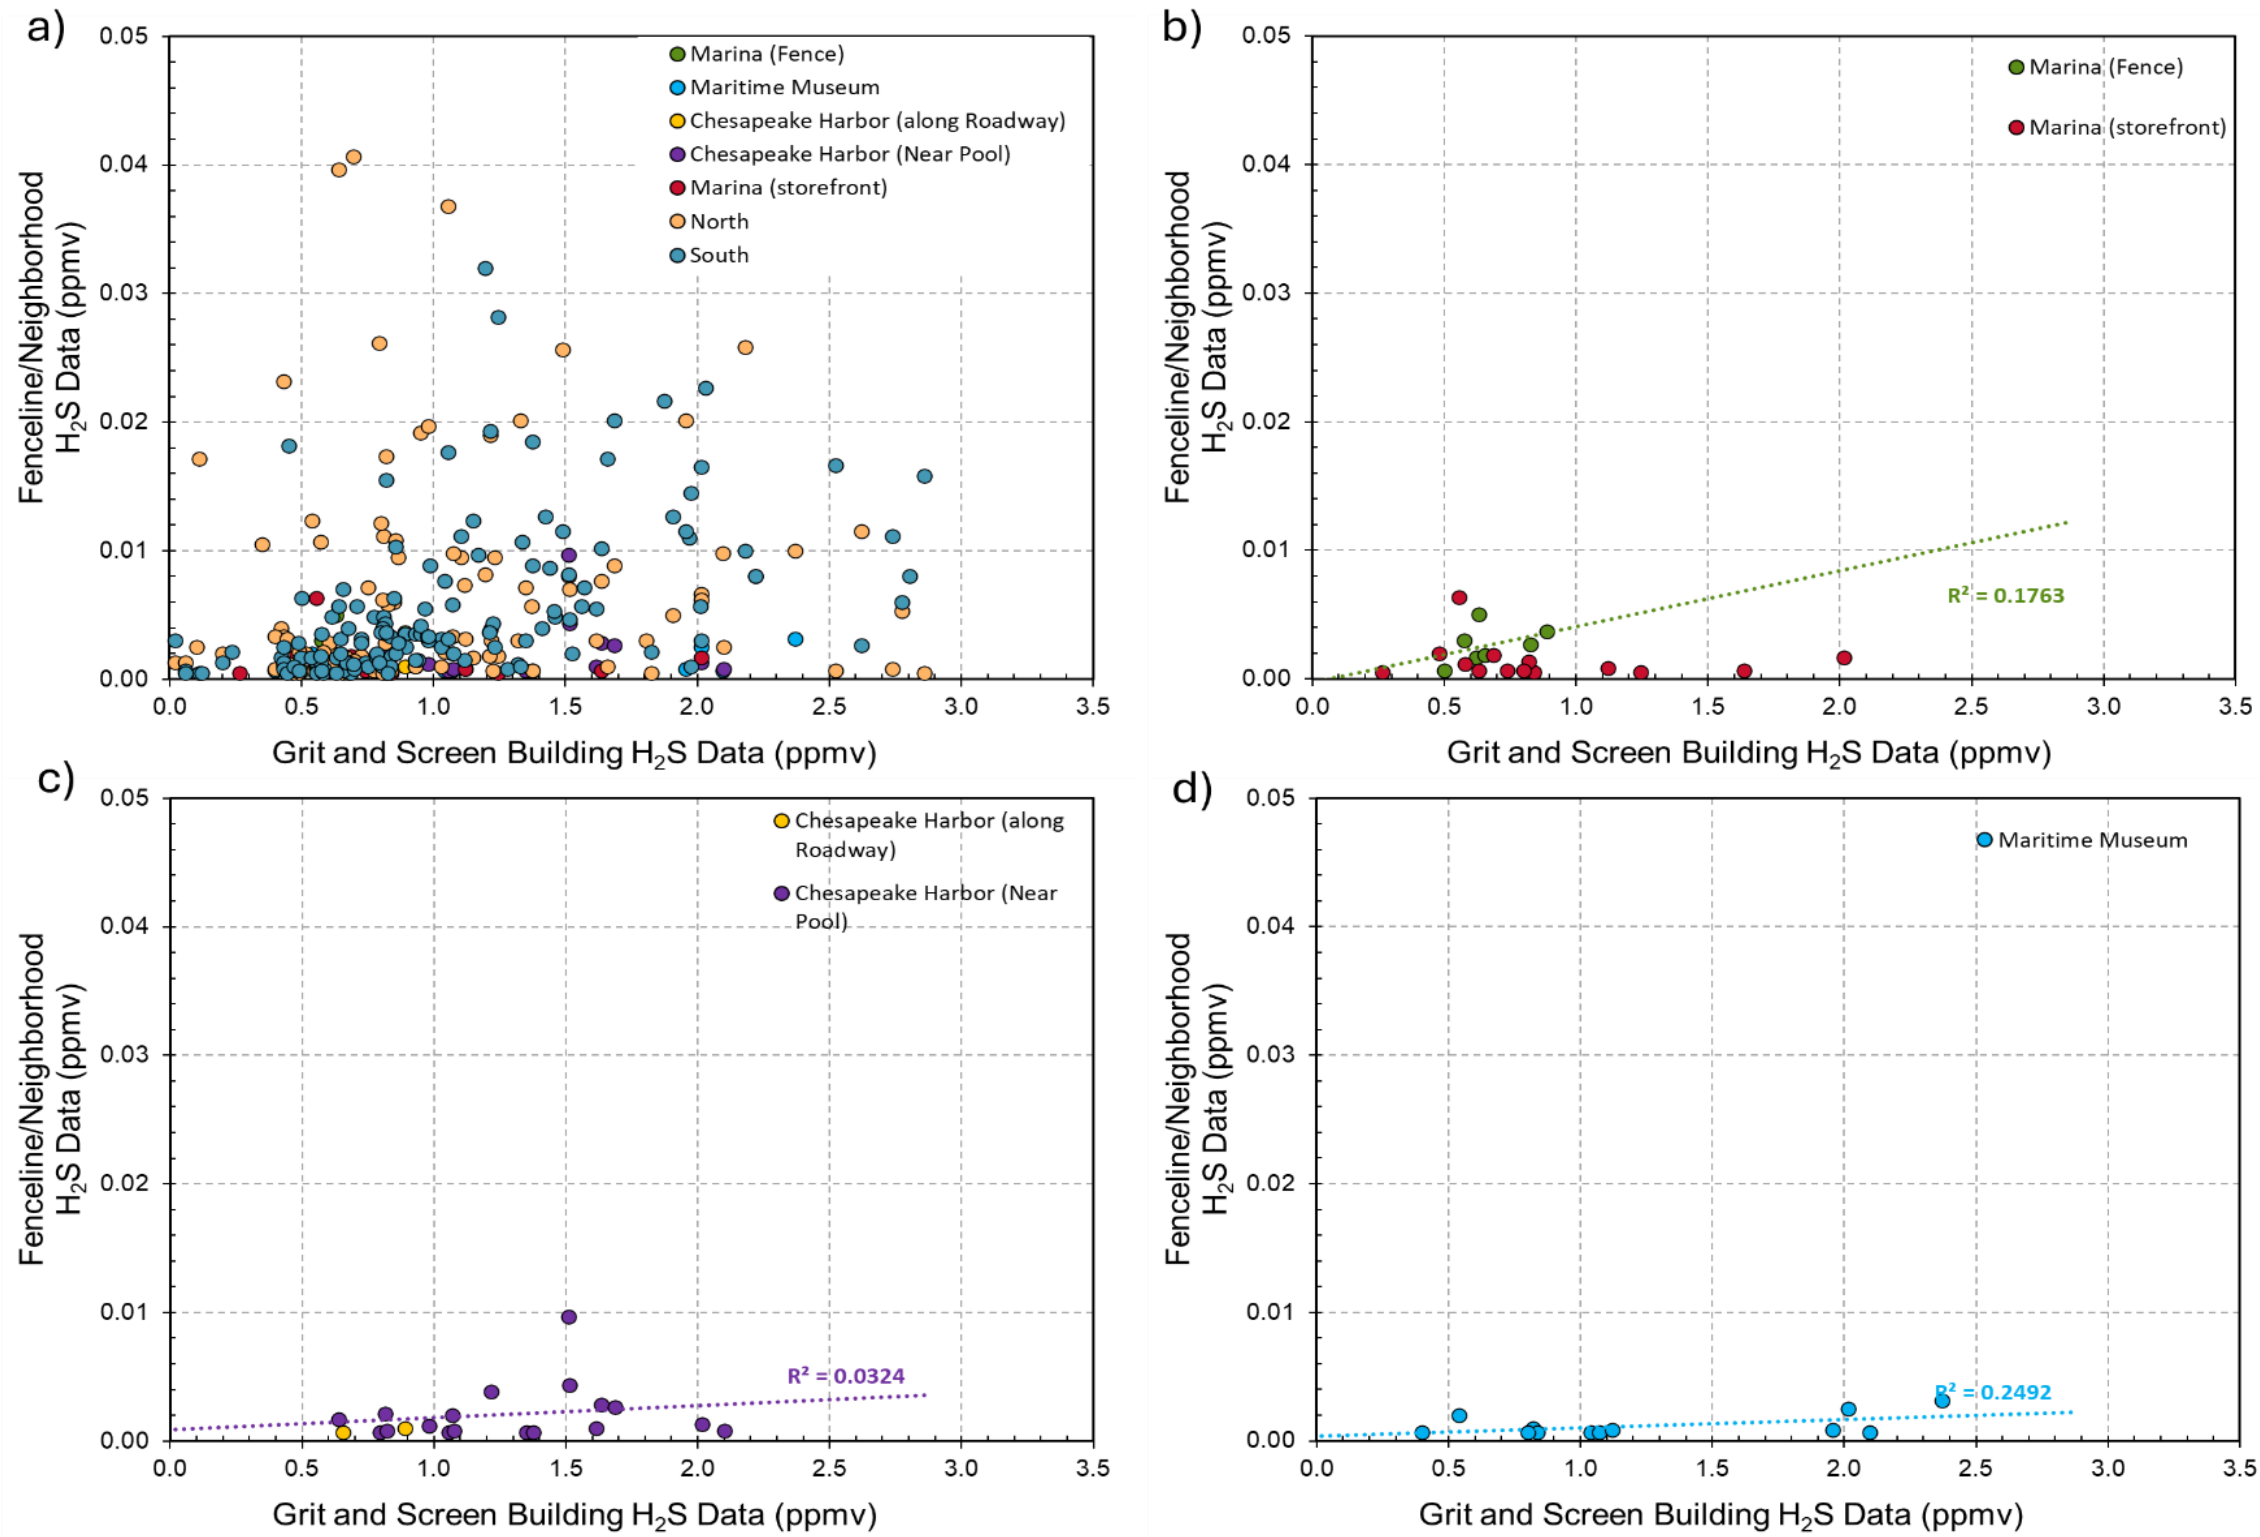
Figure 3-18 shows the correlation plot for the grit and screen building effluent data with the other PPB loggers' data. No strong correlation was observed between the odor emissions from the IPS effluent and any of the fenceline or neighborhood locations during this round of odor monitoring. Even though the marina fenceline and the maritime museum are slightly farther from the grit and screen building, a slight correlation was found between the data from these locations and the grit and screen building effluent data. Therefore, meteorological data should be examined in conjunction with the H₂S logger data to better understand the dispersion of odorous air into the neighboring areas.

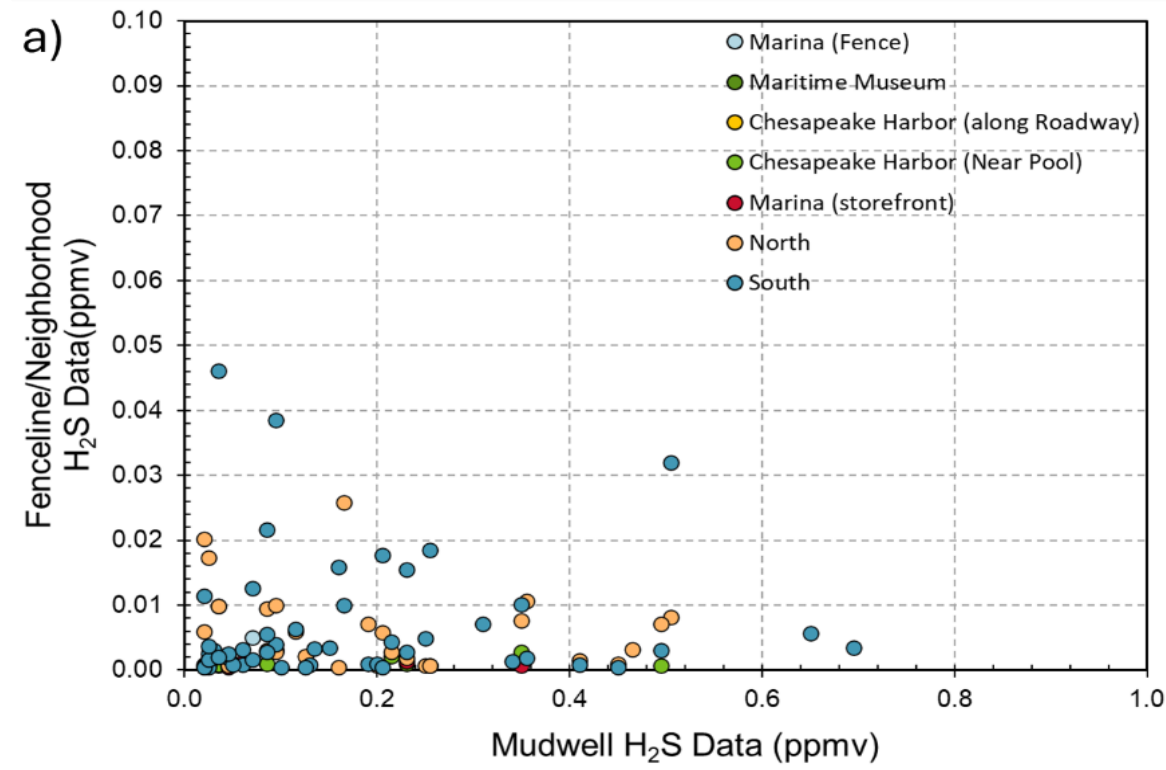
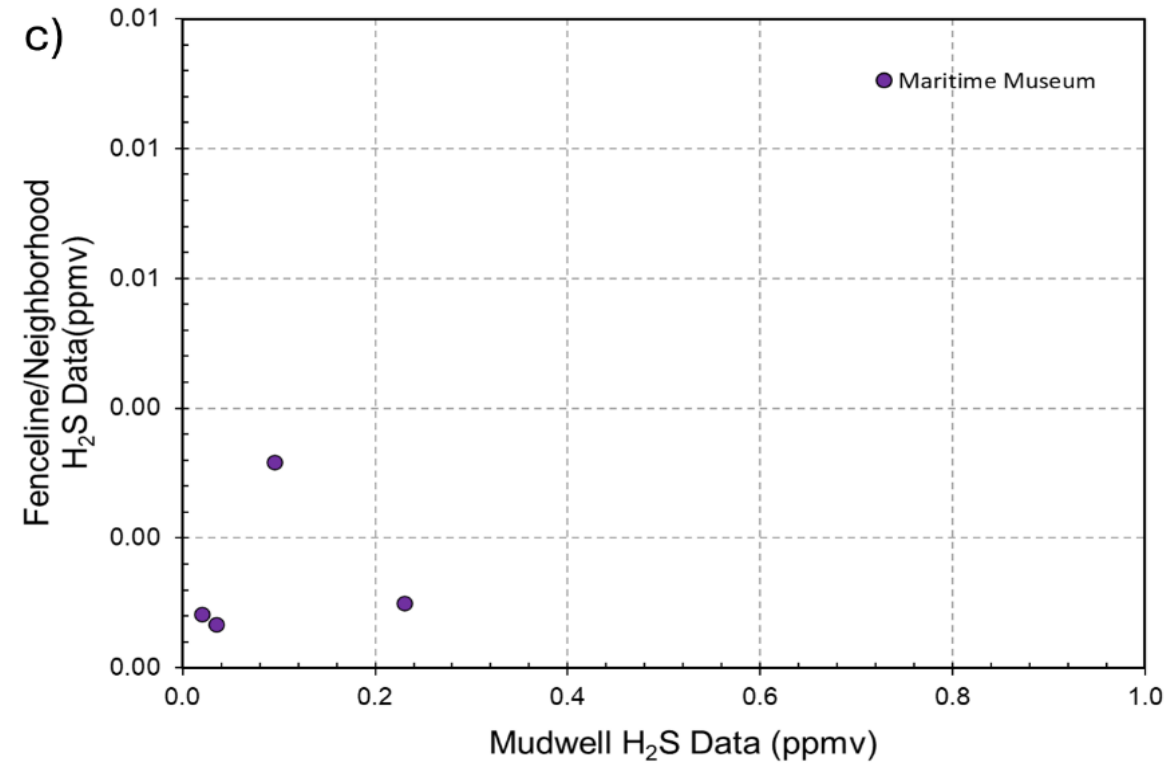
Figure 3-20: Hourly Time-Averaged Concentrations: Fenceline and Neighborhood Data Plotted against Mudwell Data

Figure 3-20 shows the correlation plot for the mudwell data with the other PPB loggers' data. Similar to the above findings, no direct correlation was observed between the odor emissions from the mudwell and any of the fence line or neighborhood locations during this round of odor monitoring.

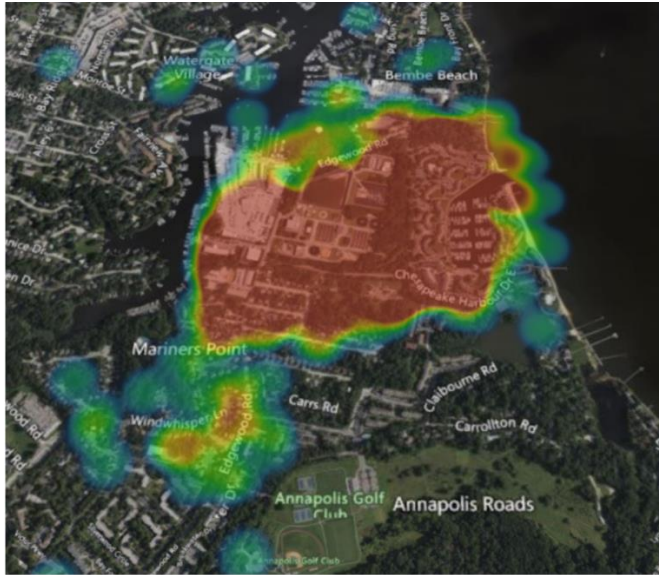
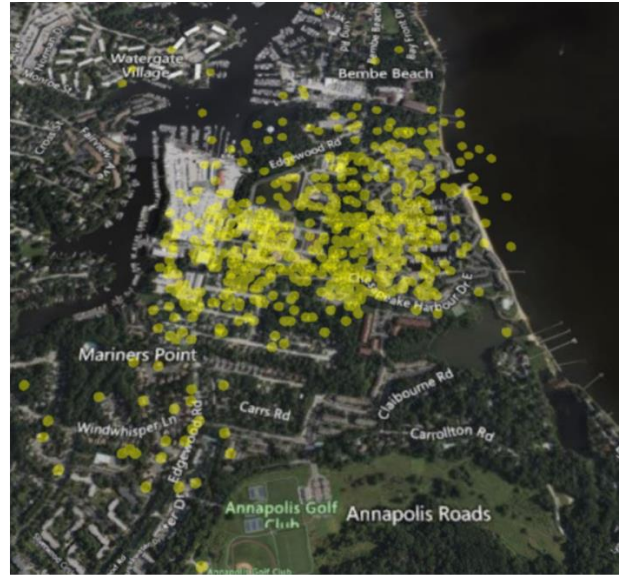
Figure 3-22 Odor Complaints Logged on Smell My City App During July 1 to August 16.

Heat map showing where most of the complaints are coming from.

Scatter plot showing the locations of individual complaints (same data shown differently)

Local residents have been using the “Smell MyCity” app to document odor nuisance complaints. The team gathered information from the Smell MyCity app to evaluate and correlate the odor nuisance complaints with the data recorded by the loggers. Figure 3-22 presents a heat map and a scatterplot showing where the majority of complaints were reported during the sampling period from July 1 to August 16. During the summer monitoring period, the complaints were concentrated around the WRF, while in the winter monitoring period, most complaints originated from the east of the WRF. Figure 3-23 shows the number of odor complaints per day for the sampling duration (July 1 - August 16) overlaid on H₂S data recorded from the neighborhood monitors. Although it appears that complaints were logged when the monitors recorded H₂S spikes, a clear correlation was not observed between the two, as a considerable number of complaints were logged even when the loggers recorded negligible levels of H₂S.

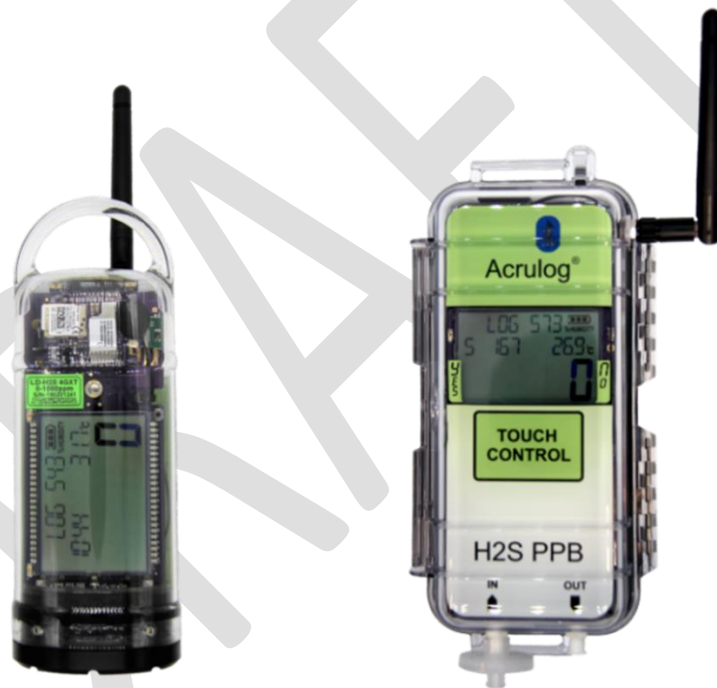
Figure 2-1 Photos of Acrulog H₂S Gas Monitors: Parts Per Million (left) and Part Per Billion (right)

The County will purchase (through HDR) ten H₂S data loggers for this odor evaluation study. Six of the loggers are Parts Per Million (PPM) monitors, preferred for source locations within the plant, while the remaining four are Parts Per Billion (PPB) monitors, preferred for fence line locations where the concentrations are lower than those at source locations. An example of Acrulog™ H₂S PPM and PPB monitors are shown in Figure 2-1.

These H₂S gas monitors are portable data-loggers, designed to track continuous data for extended periods of time and to withstand the harsh environments typically found within the wastewater industry. These monitors can be attached directly to the fence or structure with zip ties or other forms of connection. The collected data is easily downloadable via Bluetooth wireless technology. HDR, in collaboration with County staff, will install the data logging monitors. Additionally, HDR will be responsible for the weekly tasks of data collection and battery replacement.

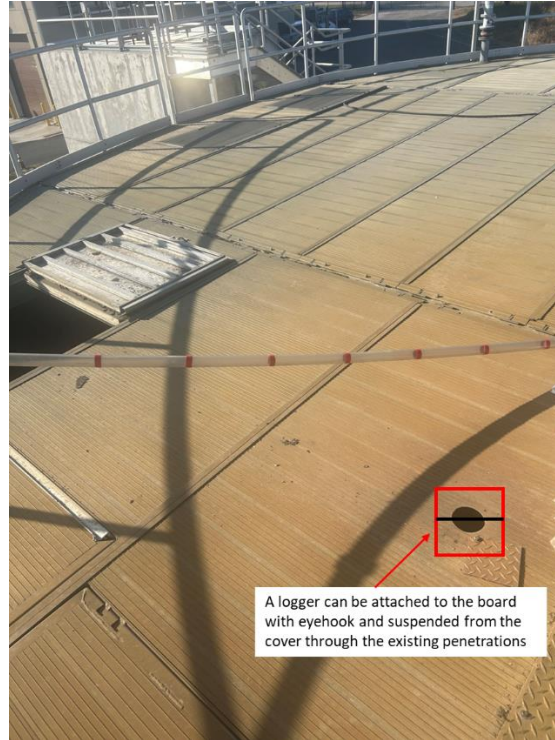
Figure 2-6 Gravity sludge thickener PPM monitor location

There are five gravity sludge thickeners (GSTs) at the Annapolis WRF. Each GST is completely covered and (similar to the primary clarifiers) ventilated to the aeration blowers for odor treatment through the activated sludge system. To identify design criteria for a future odor control system, an H₂S PPM monitor will be installed beneath the covers during the monitoring period. It is advisable to keep the covers closed to obtain representative data. Alongside continuous H₂S monitoring, colorimetric tubes will be employed for periodic measurements of organic sulfur compounds and ammonia. During the site walk conducted on December 21, it was identified that the monitor can be hung from the covers using existing penetrations (see Figure 2-6).

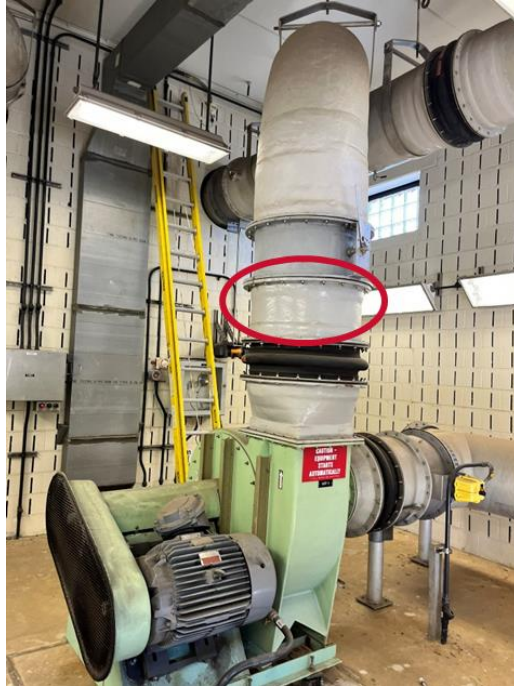
Figure 2-7 Proposed H₂S monitoring location at the aeration blower facility

Supply air for the existing aeration blowers currently is provided by the odorous air ventilated from the primary clarifiers and GSTs. To identify design criteria for a future odor control system, an H₂S PPM monitor will be installed on the discharge of the existing odor control fans (providing the supply air to the aeration blowers) downstream of the fan as shown in Figure 2-7. The bucket method will be employed to tap into the pressurized location downstream of the fan. During the site walk, it was observed that there are no existing sample taps in the blower building. A new sample tap will be drilled at the proposed location shown in the Figure 2-7. The County confirmed they could keep one blower in operation during the study period.

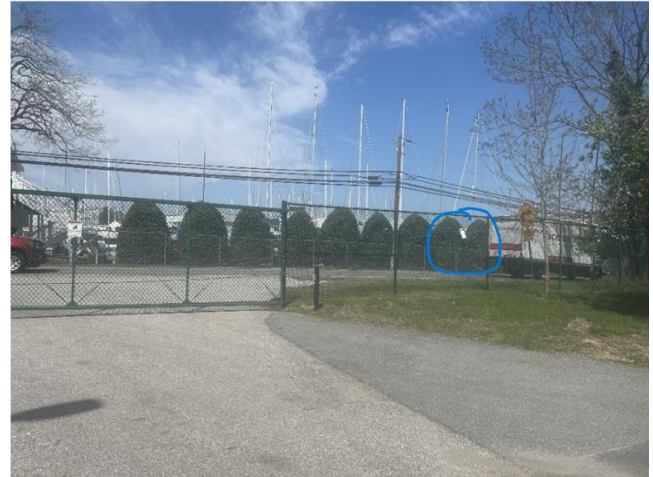
Figure 2-2 Relocated PPB Monitor Location (to the West of WRF, Close to Solids Facility)

Based on input from the Chesapeake Harbor Homeowners Association meeting with the County, the County suggested moving the northwest PPB monitor to the west of the WRF, closer to the solids facility. The relocation of the data logger was carried out on April 14, 2024, and the location is shown in the Figure 2-2.

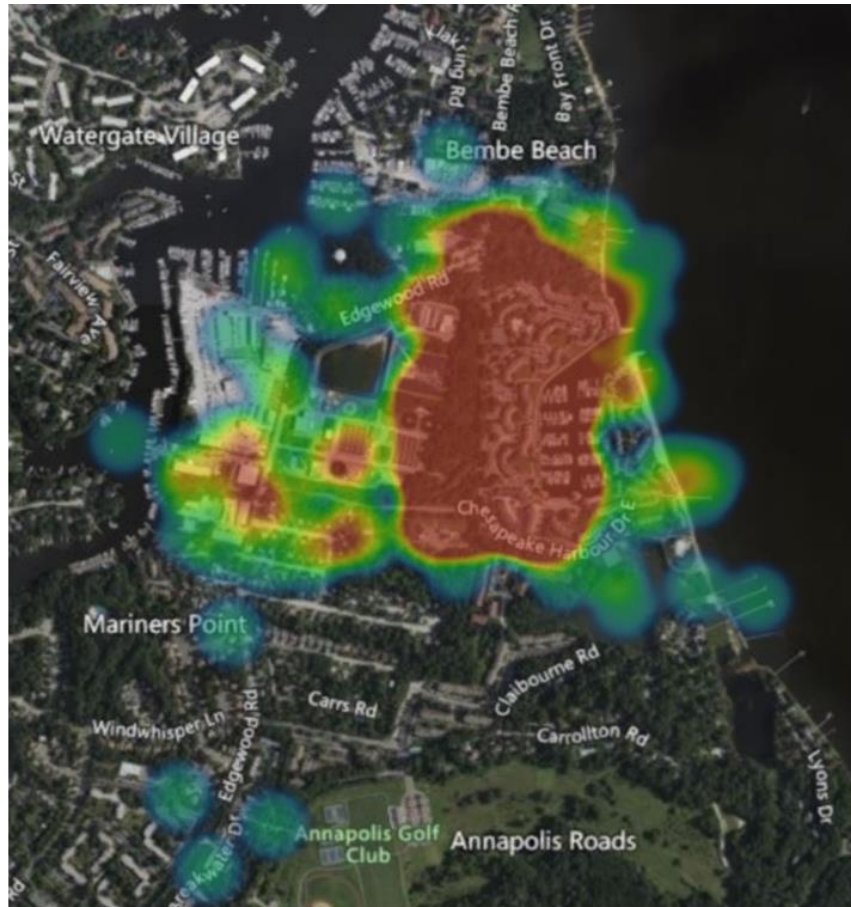
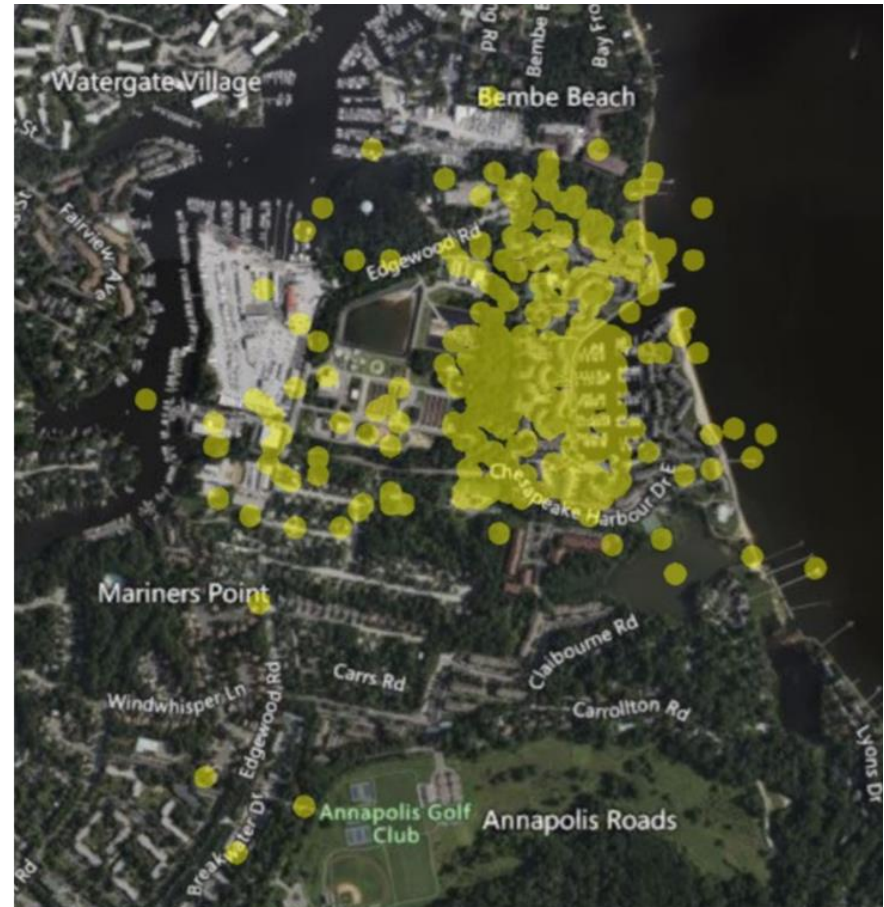
Figure 3-11 Odor Complaints Logged on Smell My City App During March 19- April 22.

Heat map showing where most of the complaints are coming from.

Scatter plot showing the locations of individual complaints (same data shown differently)

Local residents have been using the “Smell MyCity” app to document odor nuisance complaints. The team gathered information from the Smell MyCity app to evaluate and correlate the odor nuisance complaints with the data recorded by the loggers. Figure 3-11 presents a heat map and a scatterplot showing where the majority of complaints were reported during the sampling period from March 19 to April 22. Most of the complaints came from east of the WRF. Figure 3-12 shows the number of odor complaints per day for the sampling duration (March 19 - April 22) overlaid on H₂S data recorded from the fenceline monitors. The fenceline loggers to the north and northwest of the facility recorded higher frequency and magnitude of H₂S levels. Although it appears that complaints were logged when the monitors recorded H₂S spikes, a clear correlation was not observed between the two, as a considerable number of complaints were logged even when the loggers recorded negligible levels of H₂S. The south and southeast loggers recorded relatively lower frequency and magnitude of H₂S levels, and no correlation could be made with the odor complaint data either.
