Re: P468700 (Contract No. P469716) Downs Park Shoreline Improvements
30% Schematic Design

Downs Park Shoreline Improvements

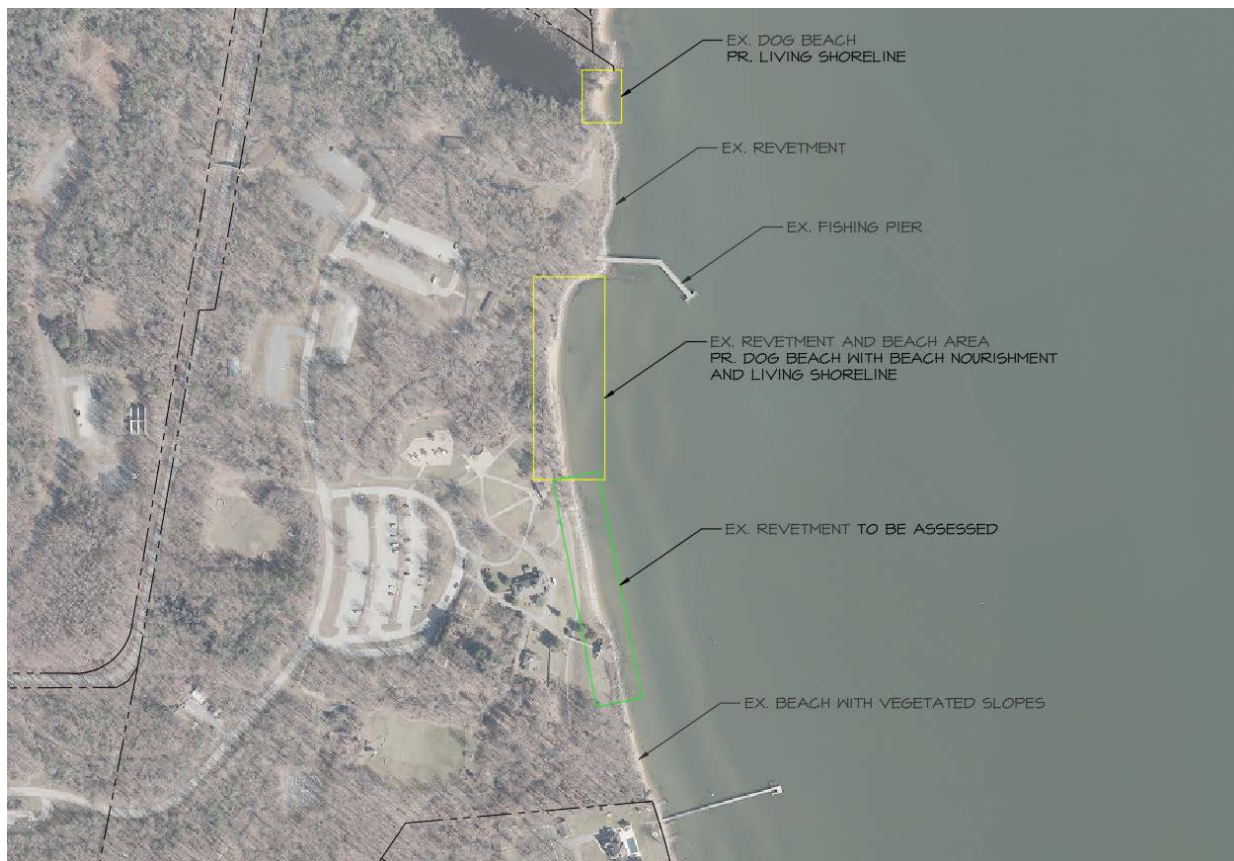
Figure 1 – Shoreline Reaches and Intended Uses

BayLand Consultants & Designers, Inc. (BayLand) has developed the following schematic design for improvements to the existing shoreline at Downs Park, located at 8311 John Downs Loops in Pasadena, Maryland. On November 16, 2022, representatives of Anne Arundel County Department of Public Works (DPW), the Department of Recreation and Parks (DRP) and BayLand met to discuss the goals and objectives of the shoreline improvements project along the Chesapeake Bay shoreline at Downs Park. Figure 1 below shows the shoreline reaches and the applications discussed during the meeting.

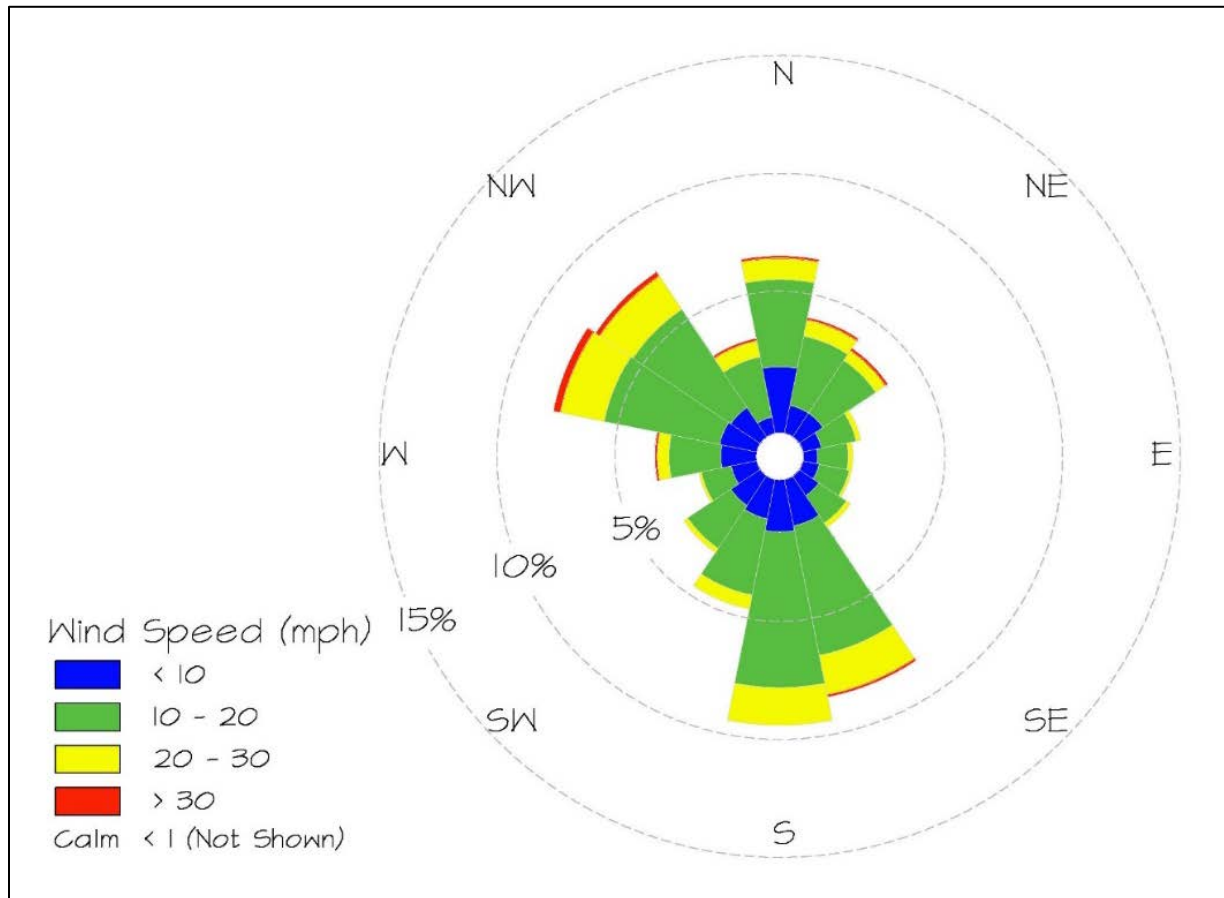
Figure 4 – Thomas Point Lighthouse Wind Rose

Wind-generated waves impact the existing shoreline and will need to be considered in the design of the structures, beach nourishment and marsh areas. Wind data from the NOAA Station TPLM2 in Thomas Point, MD, was analyzed into a wind rose which groups wind speeds by frequency and direction and is presented in Figure 4.
